# Wicklow Mountains Path Survey

<b>Corriebracks Church Mtn.</b>	
Start to Finish:	S 96709 99743 to S 95266 99906
Altitude (lowest – highest):	350m – 544m
Weather:	Sunny, dry, strong wind
Access:	Snugborough Bridge, Donard
Surveyed by:	John Monaghan 19 / 6 / 03

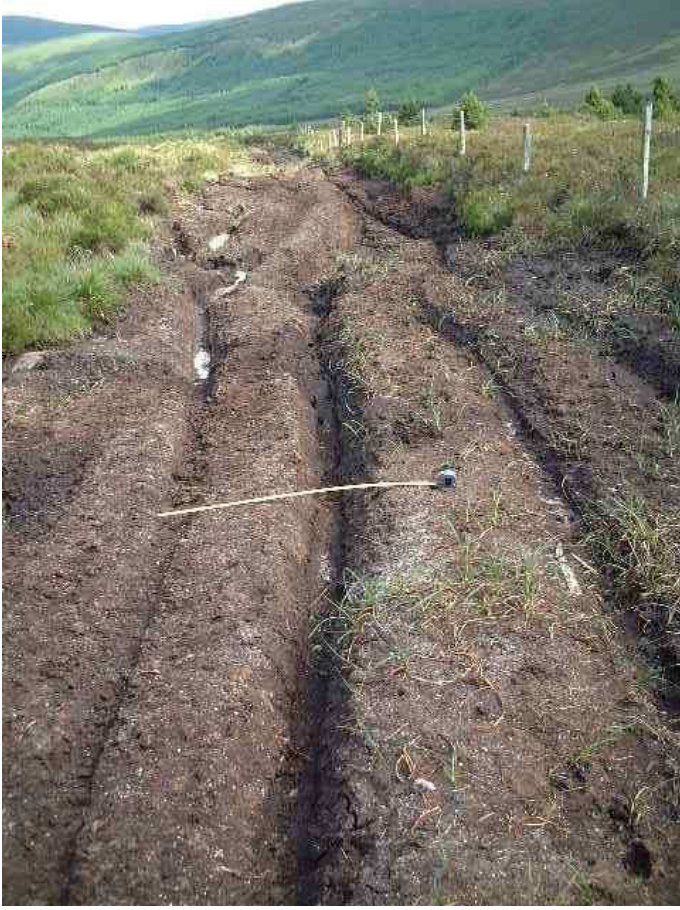
No	Pos Irish Grid S & N	Comments / Photographs
1	96709 99743	<p>Start south of Corriebracks top where the path turns left at the NE corner of the forest; Note: the forest boundary here, as shown on the OS Sheet 56 map, seems to be incorrect (see sketch below)</p> <p>there are two or more indistinct single file paths on broken peat / heather from the indistinct top of Corriebracks to this point</p>
2	same	<p>deep (30cm) tyre tracks in the soft peat; path width = 4m; new parallel paths forming up on the heather to the right</p>
3	96624 99833	<p>pic 24v looking back towards the corner shows deep ruts in the peat; tape = 1m</p>

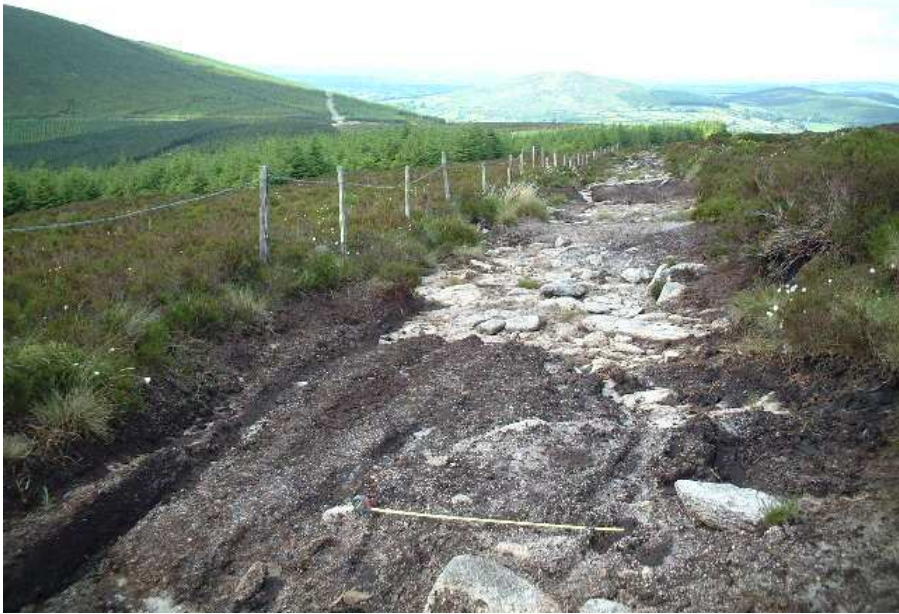
5		track turns right, still at the edge of the forest; surface again more peaty; no forest to the right as shown on the map and noted at the start
6	96280 00190	<p>pic25 looking ahead towards Slieve Corragh, east slopes of Church Mtn at top left, shows the mixed nature of the track, peat and stone; tape = 1m; path width = 4m</p>

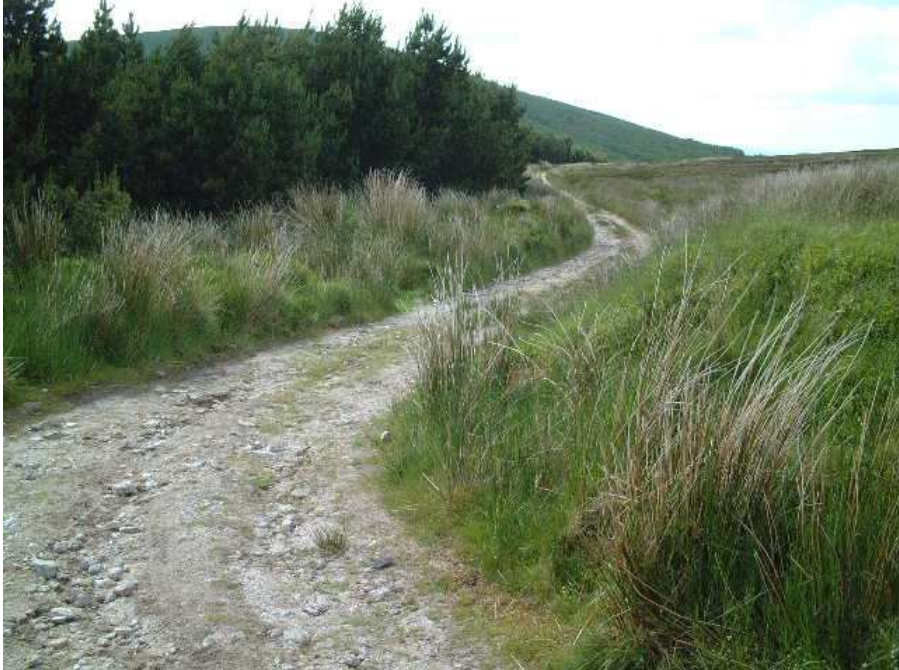
8	96044 00633	<p>track turns right; pic26 at the turn, looking ahead; width = 2m; Church Mtn ahead through the trees</p>

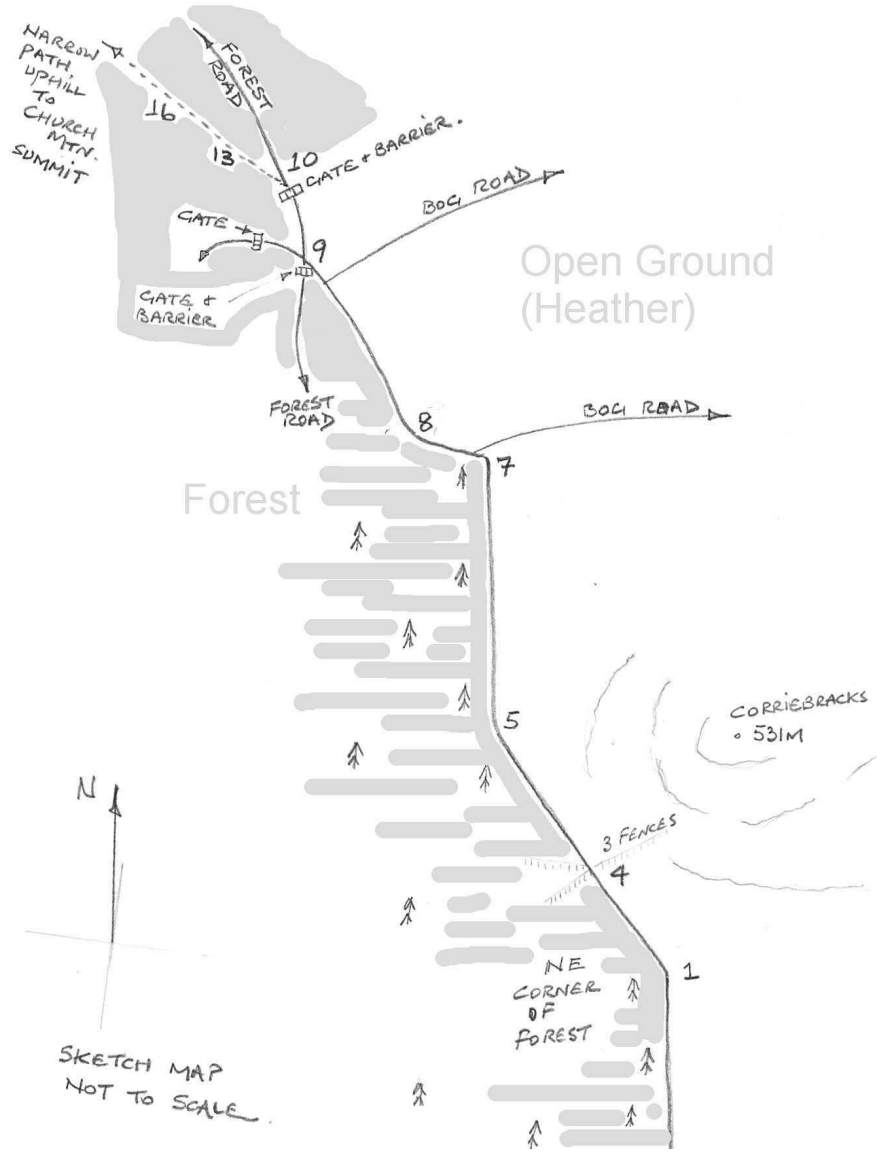
11

....another gate 160m ahead; the forest road continues on NNW uphill; inside the gate on the left a narrow path goes uphill through the forest along by a fence

pic27 shows the narrow single file path, indistinct at first, going up the slope of Church Mtn, forest on either side

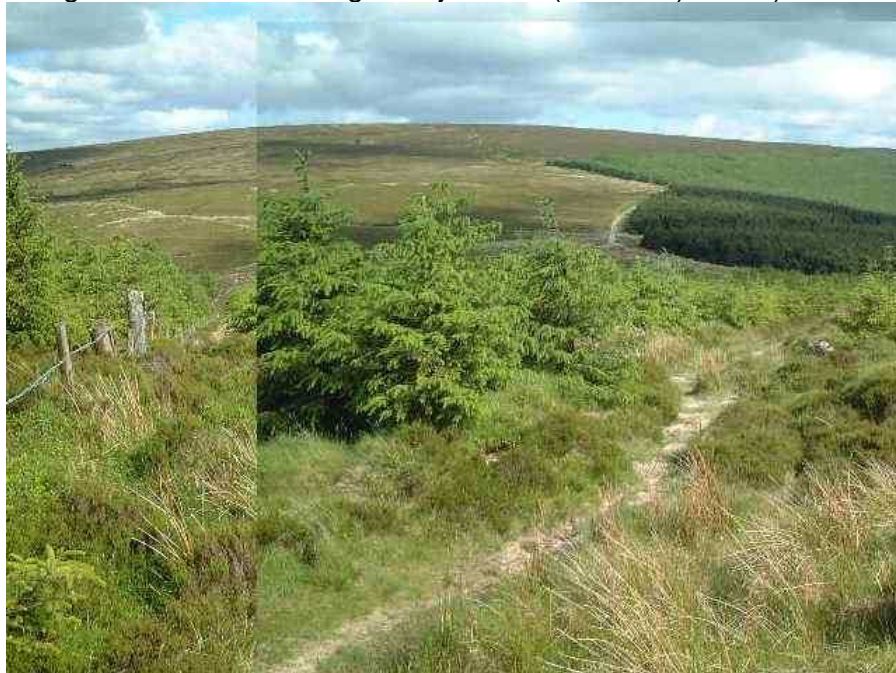
pic28/30, a composite of two photos, looking back down shows the indistinct path on the left coming up by the fence, the more mature path joining it, the route earlier along by the forest edge, the junction (no.9) at the bottom left corner of the dark area of forest, Corriebracks in the background

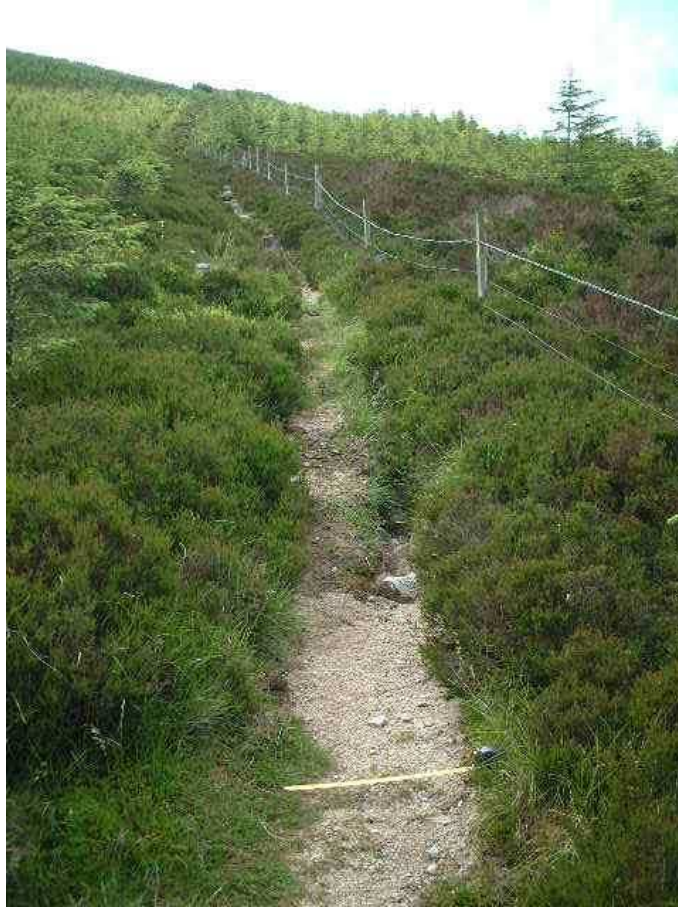
the path is now more pronounced, and a watercourse

pic32v looking ahead, tape = 0.5m, shows the first of the deep gullies (30 cms deep) on this path, just beyond the tape

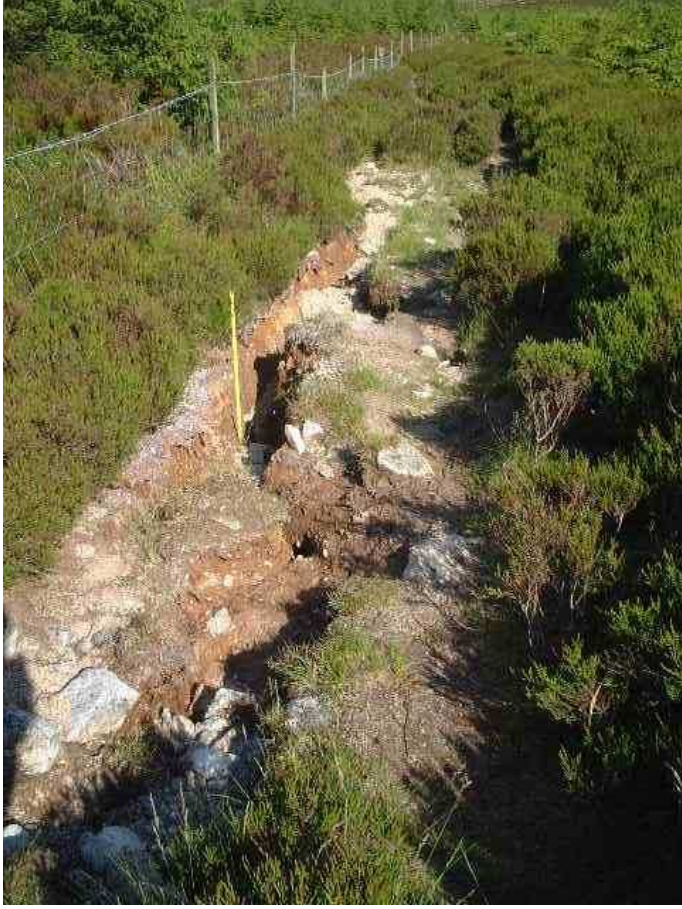
14		<p>pic33v looking back down shows deep gully going down to 80 cms; tape = 1m</p>

15	95272 01266	<p>still dramatic water erosion, gullied and the soil being washed down in wet weather; path on bare stone; at this point the path is widening to the left on the heather as walkers try to avoid the deep holes</p>

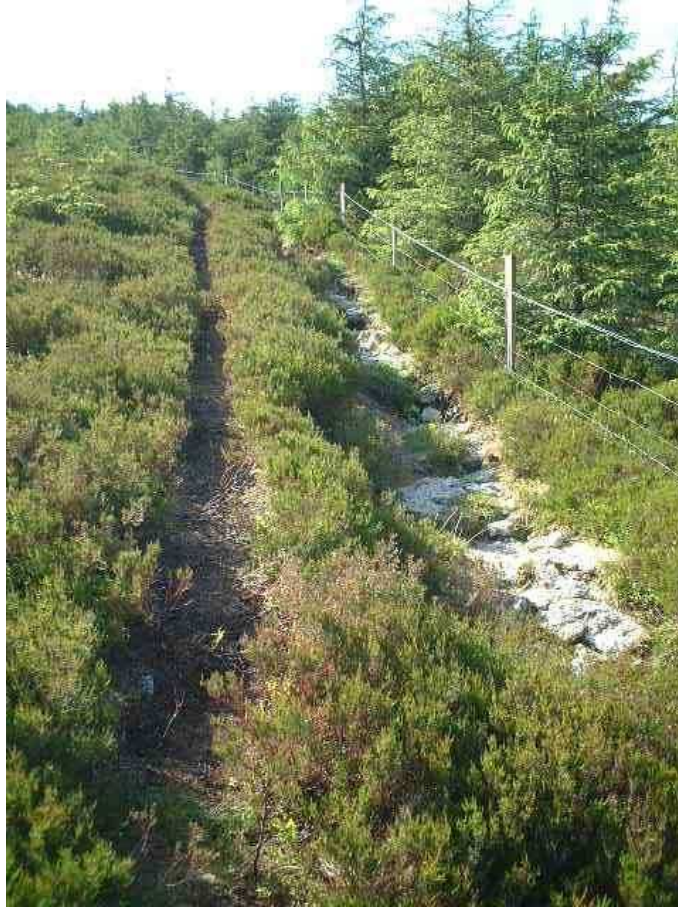
pic34v shows a parallel single file path through the heather above  
and to the left of the eroded path

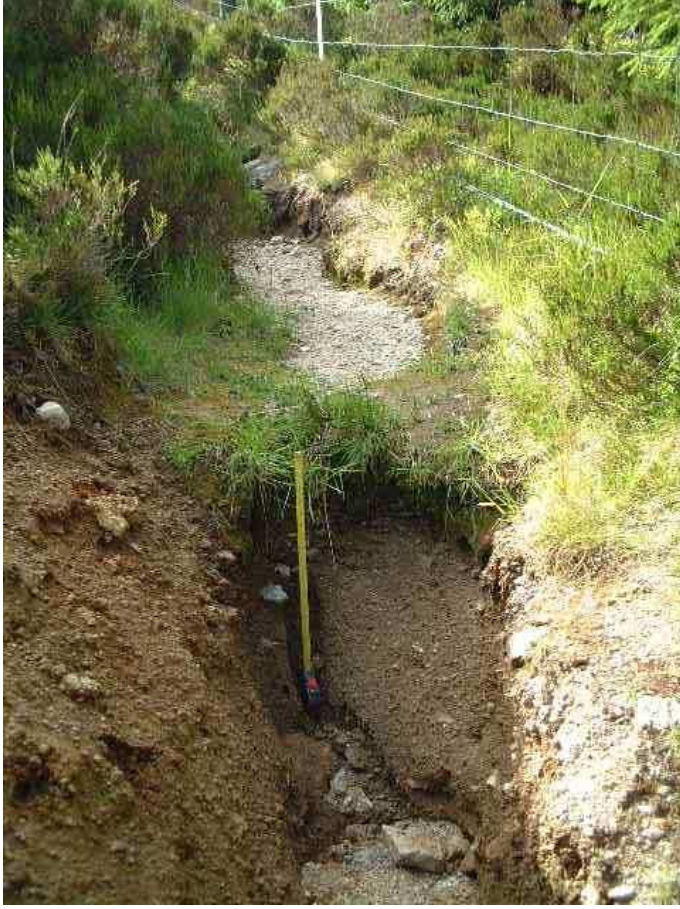
17	10m up	<p>pic35v shows a closeup of one of these holes not clearly visible in the previous photo; tape = 0.5m</p>

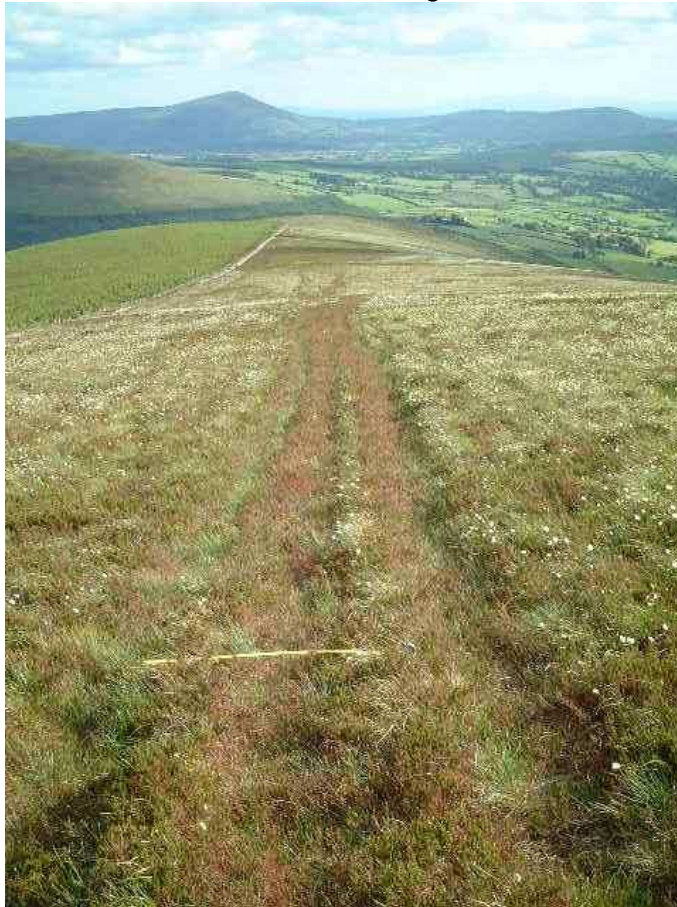
going S from the summit, pic38v shows the lightly eroded path on the south slope; the heather cover still partially intact; tape = 1m; the track which I left earlier below on the left bordering the young forest; below that again the western spur of Lobawn in mid distance; Keadeen in the background

this path can be seen to split further down as walkers make their way over to join the forest track

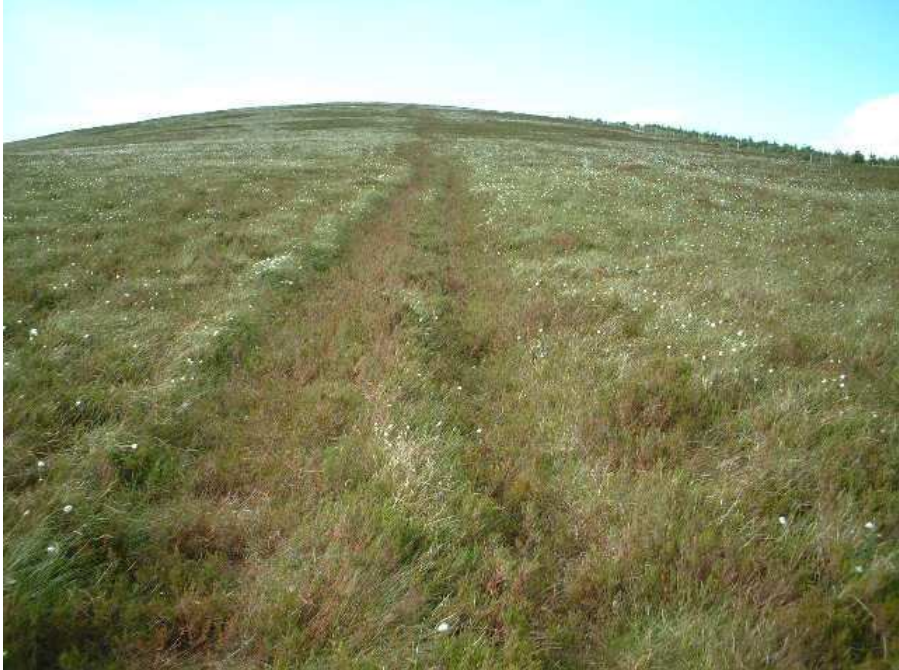
23	94918 00853	<p>pic39 looking back up shows the path to the summit; path width = 1.5m; forest can be seen top right</p>

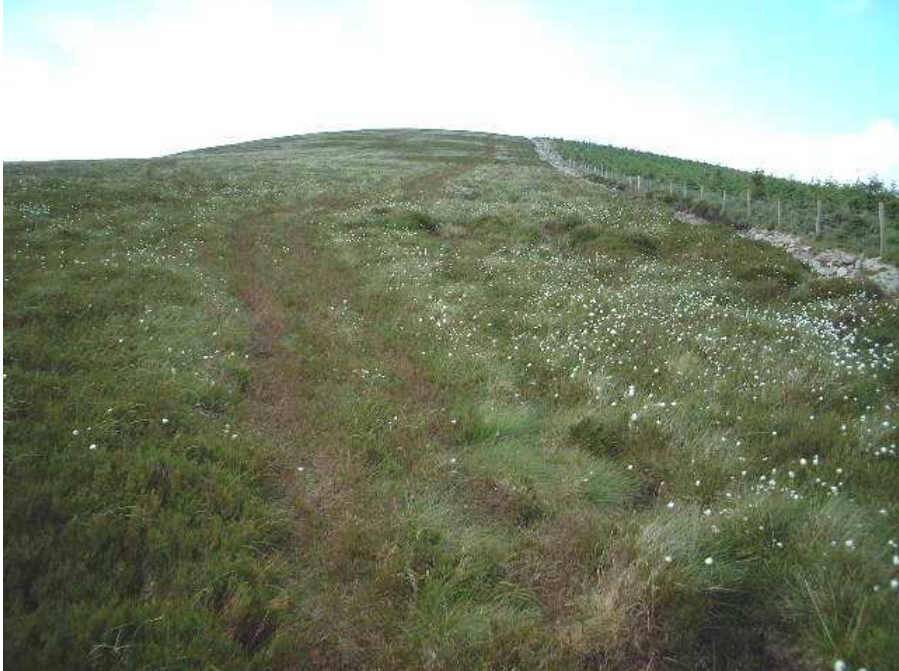
<p>pic40a looking back up, shows this extra path (2) winding its way uphill; the forest track is on the right; the surveyed path can barely be seen off to the left, nearer the summit</p>

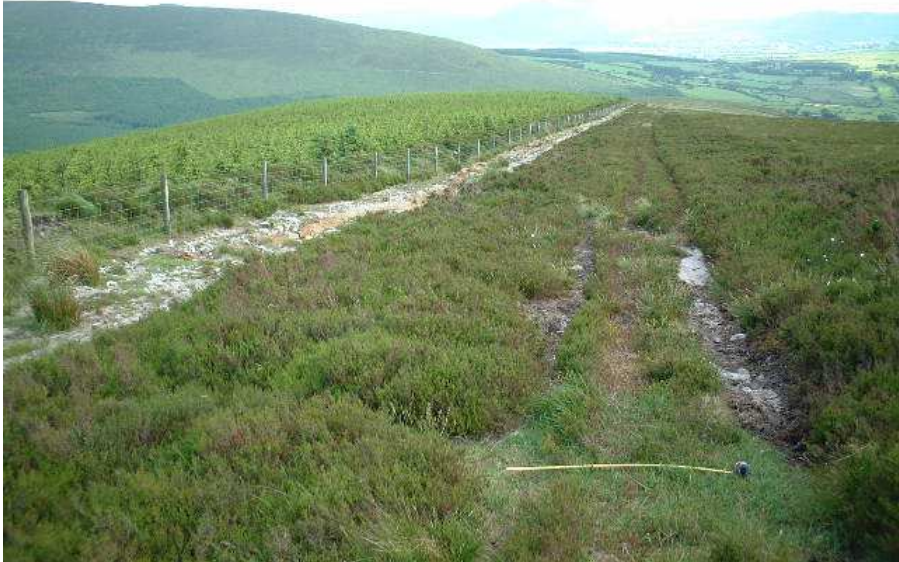
<p data-bbox="431 779 1284 877">pic41 looking downslope, shows this extra path getting more eroded as it runs parallel to, and about 5m from, the forest track; tape = 1m; the western spur of Lobawn in the background</p>
26	same	<p data-bbox="431 951 1279 1050">across from where pic41 was taken, the forest track has a 60cm deep gully running down it for a short distance, caused by water erosion</p>
27	94924 00167	<p data-bbox="431 1125 1279 1224">SE corner of the forest; Imaal Walkers 2001 wooden seat donated by Coillte at the corner; a very faint path runs straight ahead S for a few metres but peters out</p>
28		<p data-bbox="431 1299 1279 1398">the track follows the forest boundary and runs SE (mag. bearing 140°) by the edge of the forest, steepening as it approaches another forest track below running N-S</p>

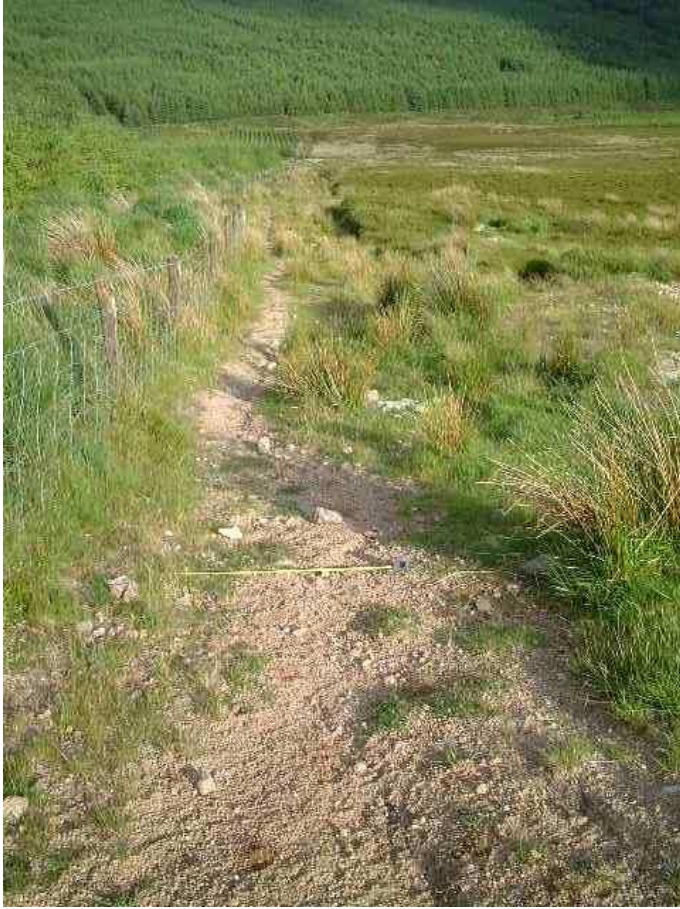
<p>pic42v looking down the slope, shows the path, the surface a mix of grass / stone; path width goes out to 3m in places, narrowing further down; tape = 1m (water damage not shown)</p>
<p>30</p>	<p>95266 99906</p>	<p>track reaches forestry track running N – S at a gate with a stile at the side and a "Unauthorised Entry Prohibited" sign</p>
<p>31</p>		<p>END</p>
