Wicklow Mountains Path Survey

Lough Bray	
Start to Finish:	O 140 ₀₀ 175 ₅₀ to O 141 ₇₀ 163 ₇₀
Altitude (lowest – highest):	370m – 555m
Weather:	Sunny, after rainy June.
Access:	Rathfarnham – Sally Gap road at start and finish given above
Surveyed by:	John Monaghan, 20 / 6 / 02

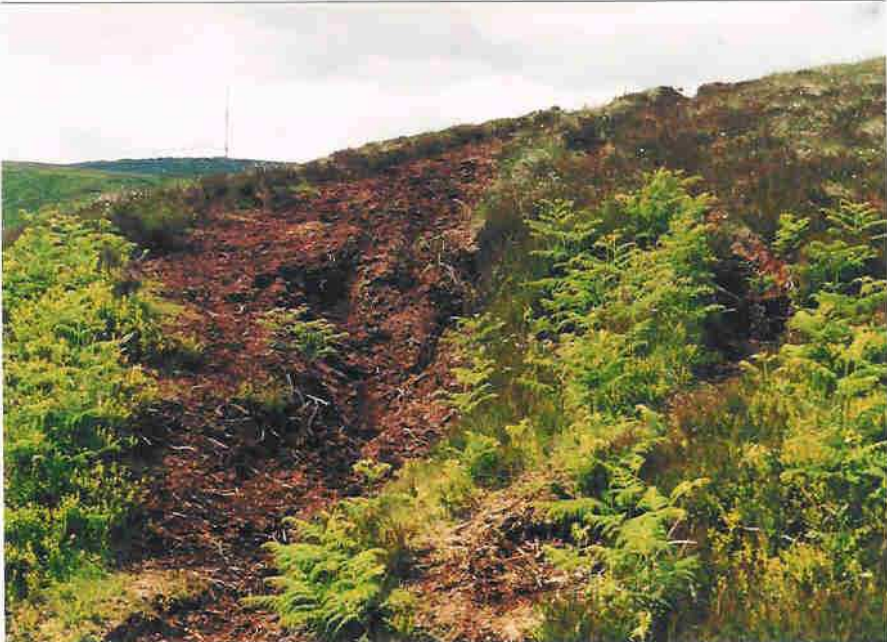
<p><u>pic37</u> looking W up the slope shows braiding, new path on the right; Kippure mast in background</p>
5	100m on up	path has divided into 4 "single file" paths
6	13425 16877	path divides; main path to the left (nearest lake)
7		path on edge of steep heather slope; single file width

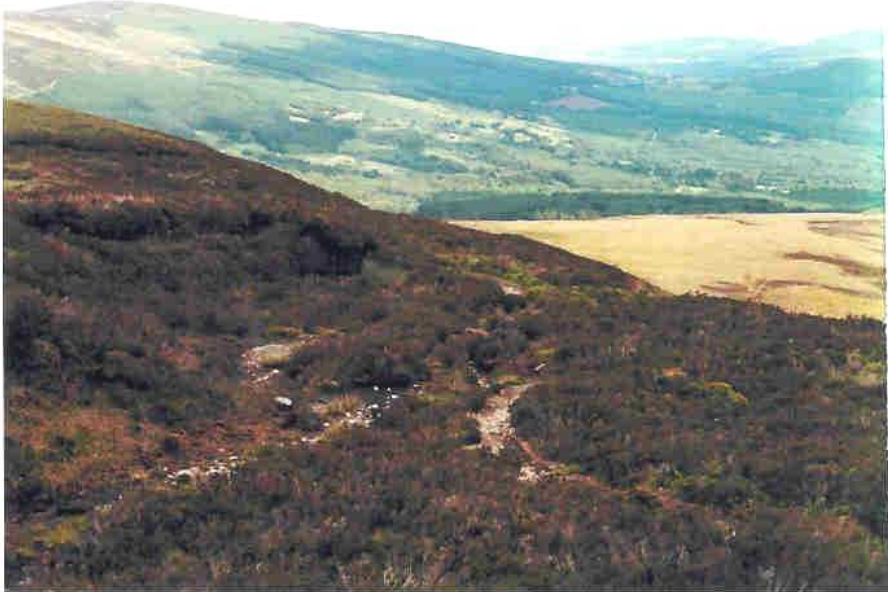
<p><u>pic38</u> looking back down (E) shows path dividing; Prince William's Seat at top-left; Glencree valley and Bray Head in background</p>
9		<p>parallel paths on soft peat 10m apart; then re-join</p>
10	13070 16688	<p><u>pic0</u> looking SW, shows eroding bank from walkers ascending / descending; Kippure summit out of sight in background</p> <hr/>

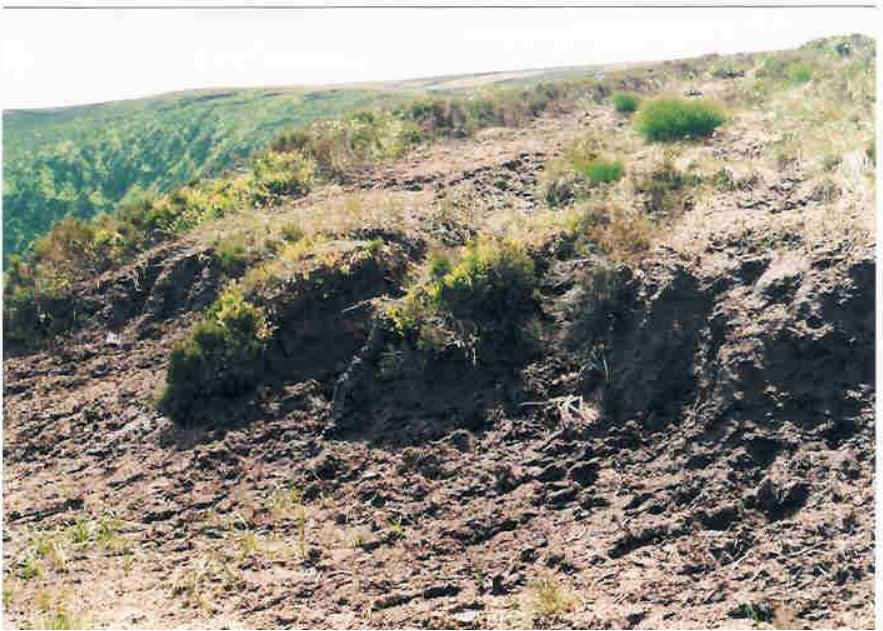
<p data-bbox="430 772 802 806"><u>pic1</u> shows same, closer up</p>
12	further on	<p data-bbox="430 877 1211 947"><u>pic2</u> shows a general view of the path ahead; tyre tracks in foreground; a need to drain water off the path here</p>

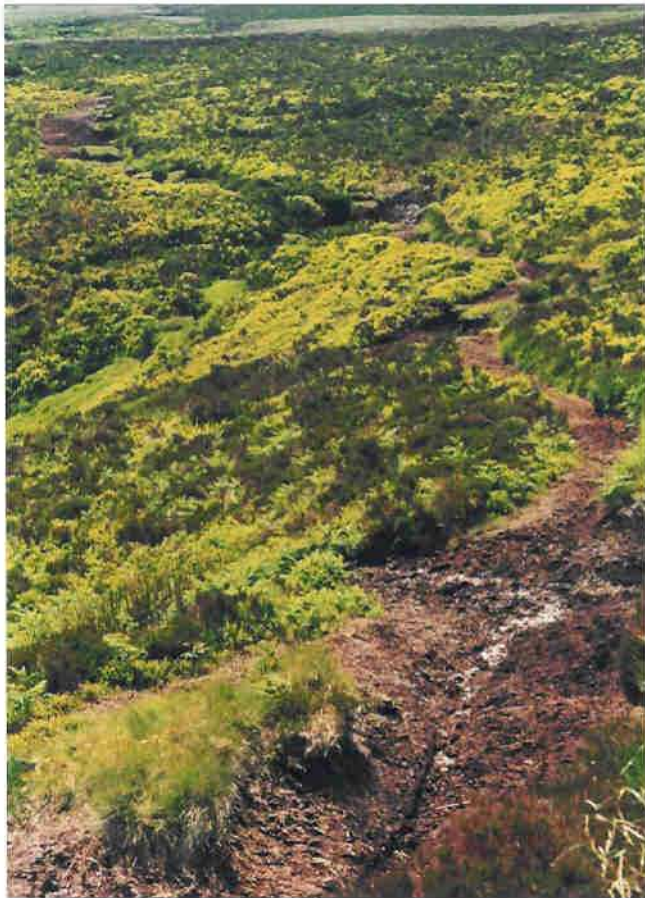
13	12958 16510	wet grassy patch and braiding followed by eroded bank
14	50m on	more braiding, just before small stream enters large gully down to the lake below; the path divides here, soon 30m apart; I followed the higher one
15	12895 16393	<p><u>pic3</u> shows path ahead ascending steep slope</p>

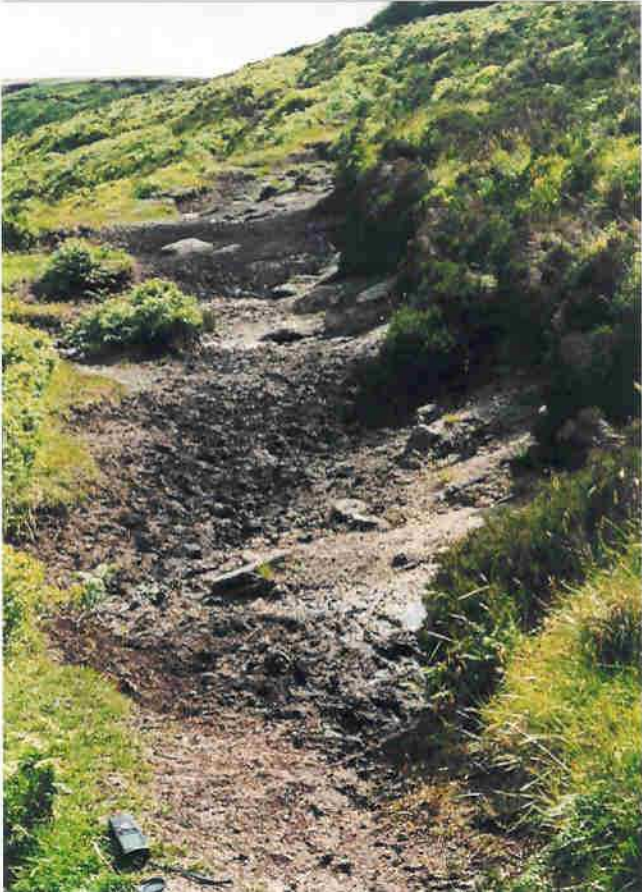
19	13129 16045	path divides again; the lower, narrower one contouring to the left; I followed the wider one going uphill to the right, crossing a small stream over a badly eroded bank
20	13274 15951	more eroding banks crossing small stream; large loose stones available here to make a bridge across to stabilise the peat banks
21	13500 15950	Eagle's Nest – numerous paths here; eroded and badly torn up area generally
22	same	path divides up again going SW from the Eagle's Nest; I took the lower path on the left
23	200m on	wet area; 3 parallel paths now close together
24	13370 15770	<p>pic6 shows wet area ; (GPS in foreground); path width \leq 4m</p>

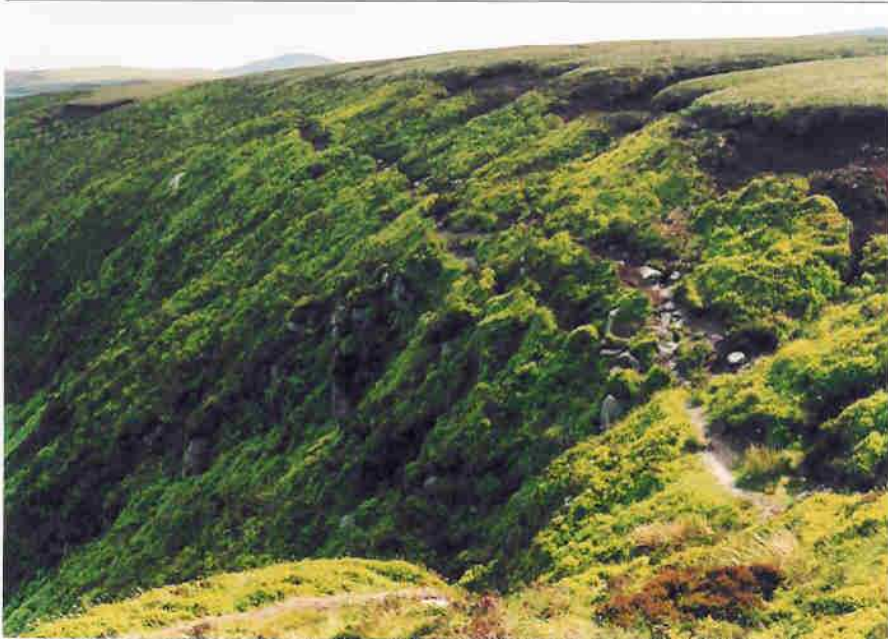
25		there are large stones further on which could be used for surfacing work
26		path in good condition, less than 1m wide at two large 2m boulders
27	13266 15536	<p data-bbox="435 390 1122 422"><u>pic7</u> shows path ahead after crossing the large gully</p>

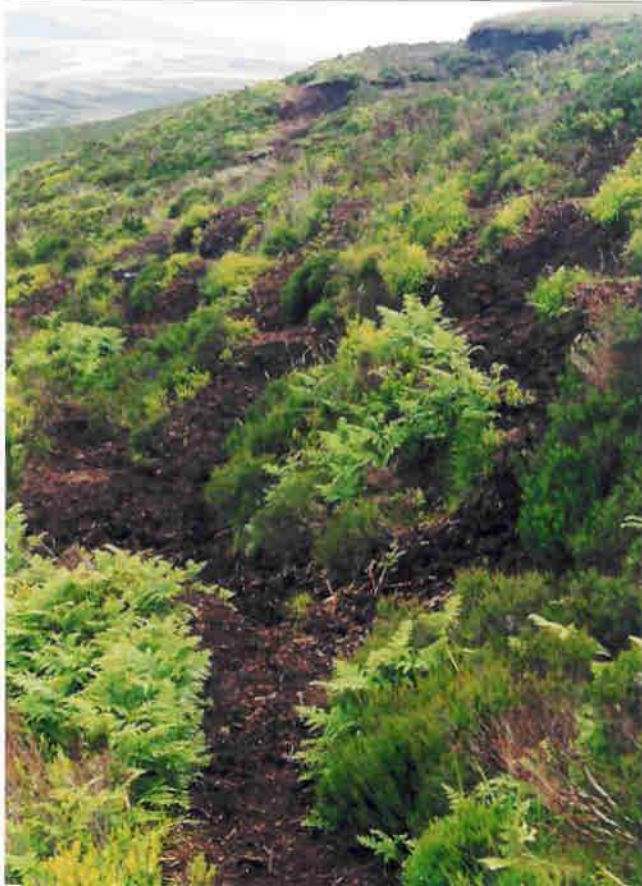
<p><u>pic8</u> shows the broken nature of the path here; very soft peat rapidly being washed and blown downslope; the slope at the far end of the photo is also badly eroded</p>
30	100m on	wet area; you have to go up and around it – it needs to be surfaced to stop path widening
31	13510 15077	the path from pic8 to here is generally good with the above exception; mostly <1m wide; however it now widens out to >2m; there is also a badly eroded bank here
32		the path above Upper Lough Bray is generally good until the end of the lake, but ...

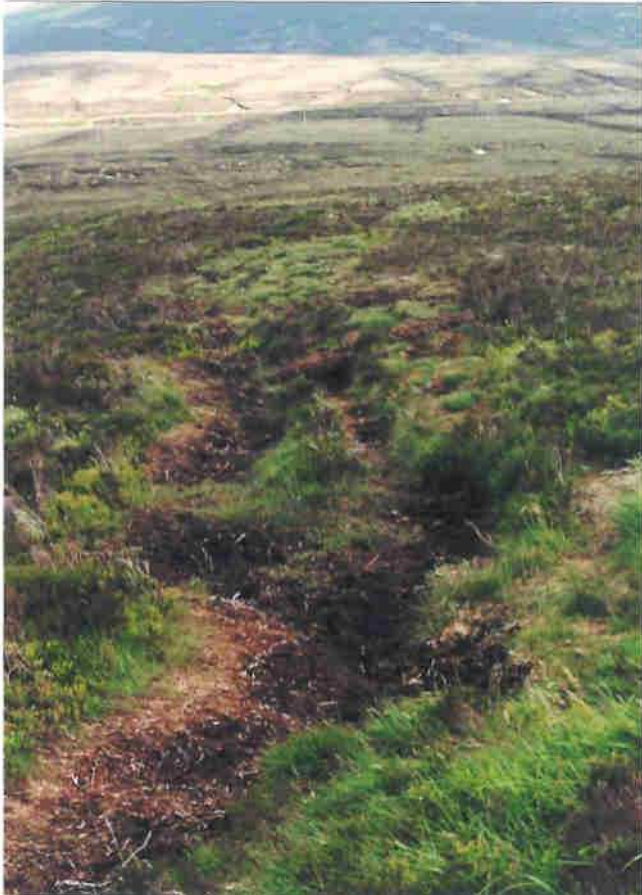
<p><u>pic9</u> shows the path; path width = 3.5m; the road can be seen below</p>
34		just below this a drain crossing the path at right angles needs to be bridged to prevent any more path widening
35		an indistinct path goes straight on down towards the road; the main path turns sharp left towards the lake
36	13765 14950	wet area here and for the next 100m
37	13856 14994	two minor paths come down from the right to join the main path

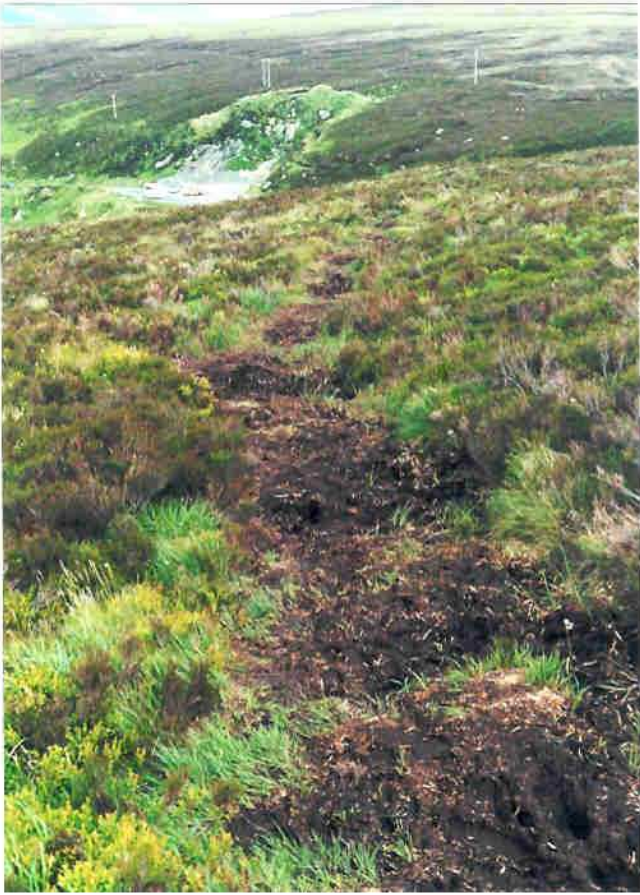
38	14003 15024	<p>pic10 shows the path and the quarry below (white bus, two cars, one burned out); the foreground shows the peat to be very soft and deep (>60cms); it will quickly erode with increased trampling</p>

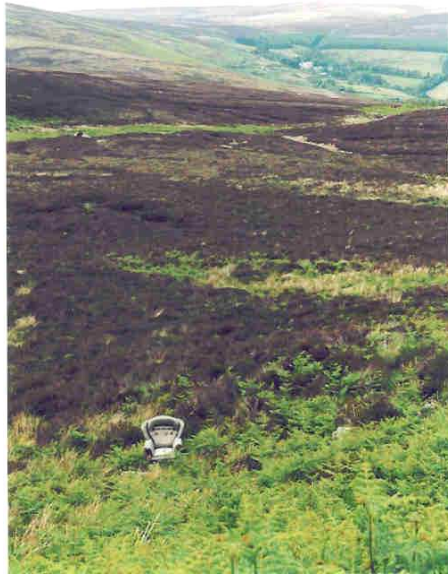
pic11 a welcome place to rest at the end of a long day

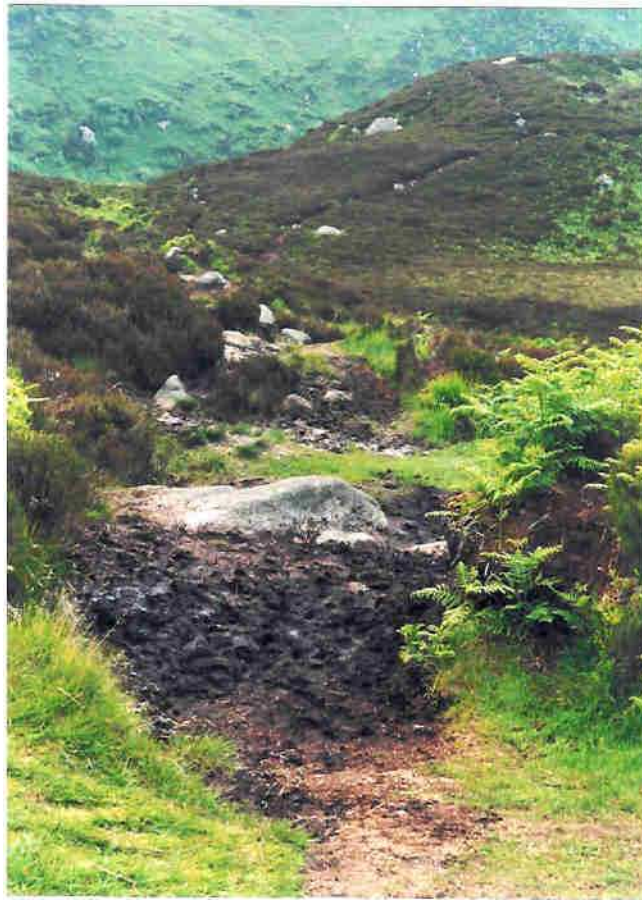
pic12 shows state of path halfway to the Upper Lake; it is very broken up and wet; one definite path is needed here; materials available close by; also easy access from road

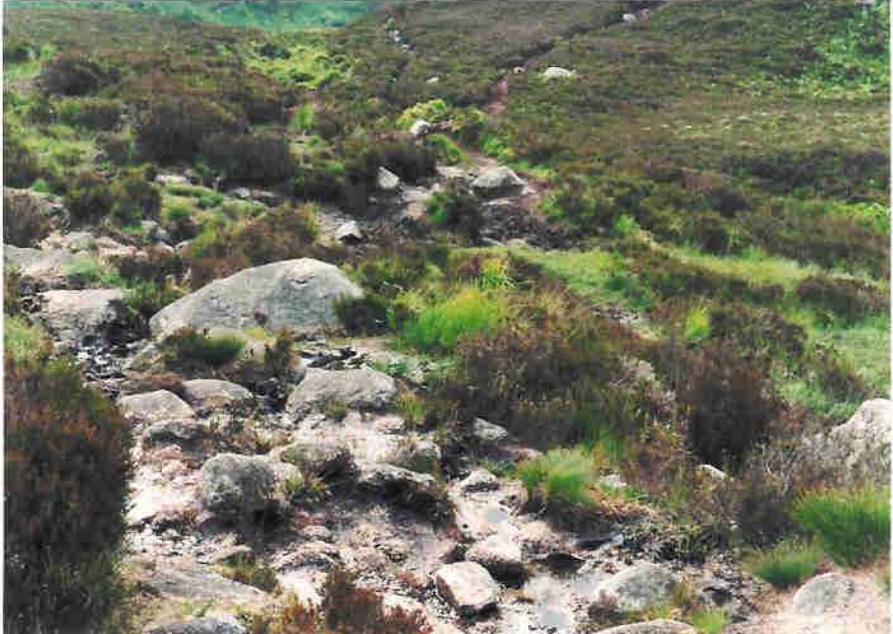
44		<p>pic13 small distance further on</p>

45		<p>the slope up to the top of the moraine is in bad condition (combination of steep slope, peat surface and trampling); the path surface and width improves along the top</p>

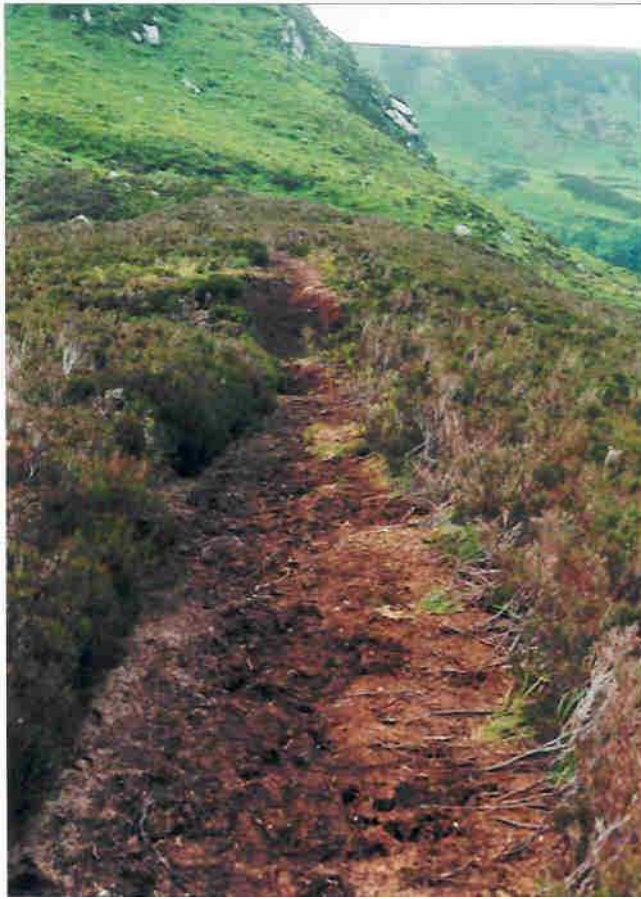
pic14 shows the worst part of the path along the crest of the moraine; 1- 2m wide; the Eagle's Nest is out of sight straight ahead and above; a narrow minor path goes down left to the lake shore from here; I turned right here, away from the lake

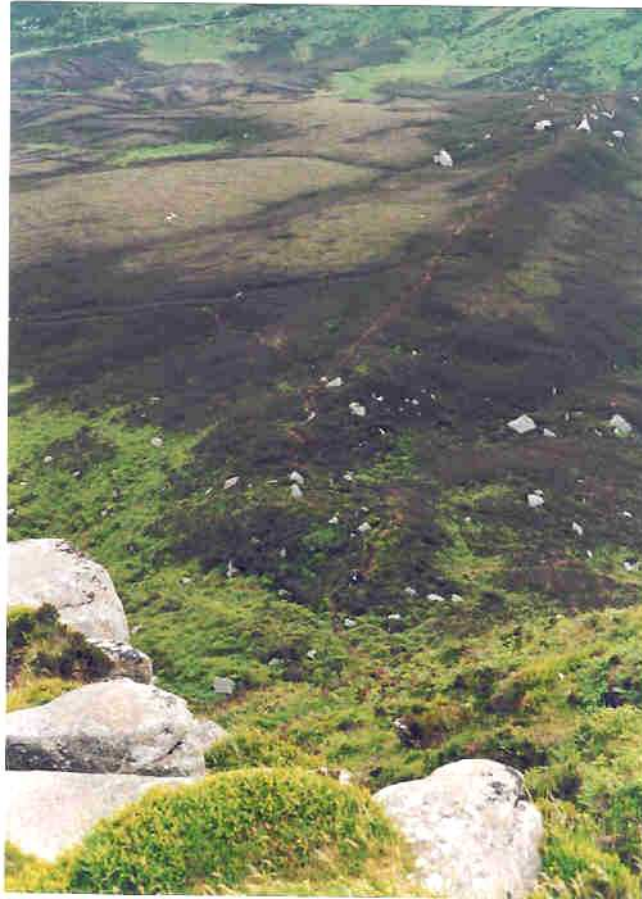
pic5 looking down from the Eagle's Nest, shows an overall view of the path along the top of the moraine, and the turn down towards the finish of the route

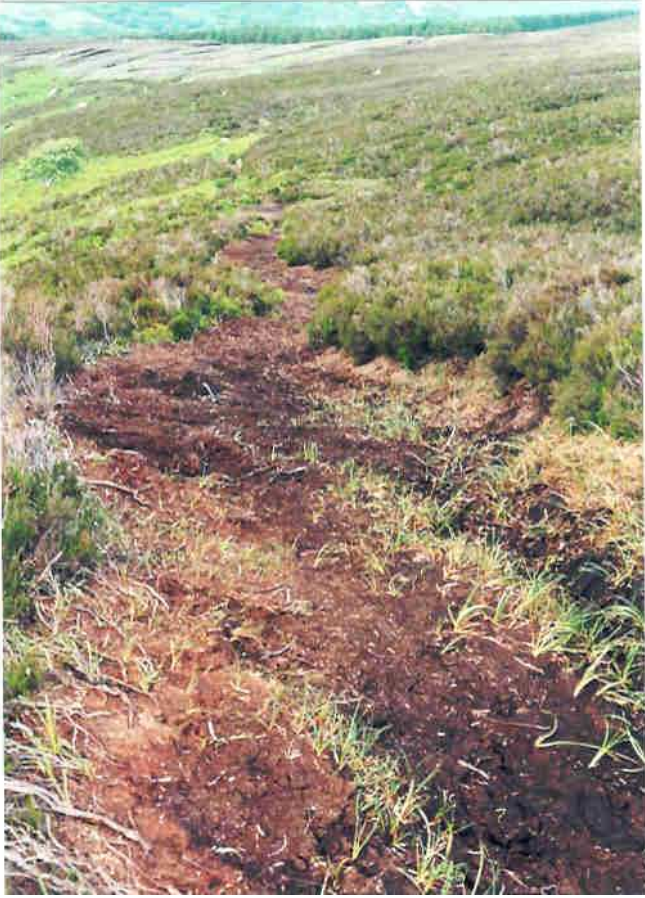
47	10m on down	<p>pic15 shows the path downslope in very poor condition; eroding and widening</p>
