Wicklow Mountains Path Survey

Maulin east	
Start to Finish:	O 1923 1207 to O 18438 13088
Altitude (lowest – highest):	330m - 570m
Weather:	Windy, overcast, after rain in the morning
Access:	Crone forest car park
Surveyed by:	John Monaghan, 30 / 7 / 02 and 8 / 6 / 03

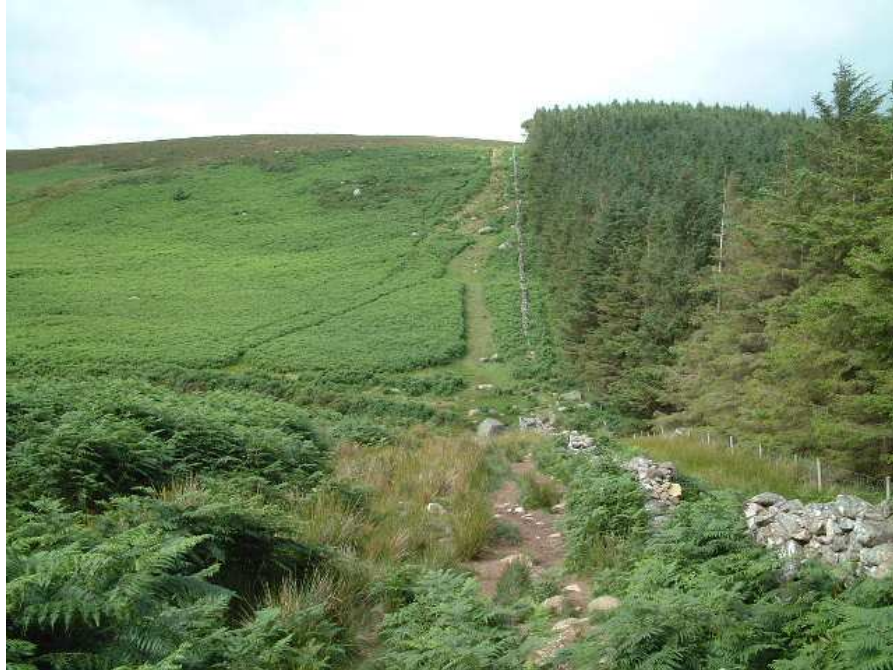
The path here, part of the Wicklow Way, is a watercourse in wet weather with deep gullies from water erosion;

The path from the bridge, on grass is initially = 4m wide, widening out to a total width of 15m higher up

Going north up the steep slope, it is badly pockmarked, the mineral soil being washed down / blown away; in places down to bare stone

pic88, from the far (south) slope, shows the path from the bridge up, widening as it ascends

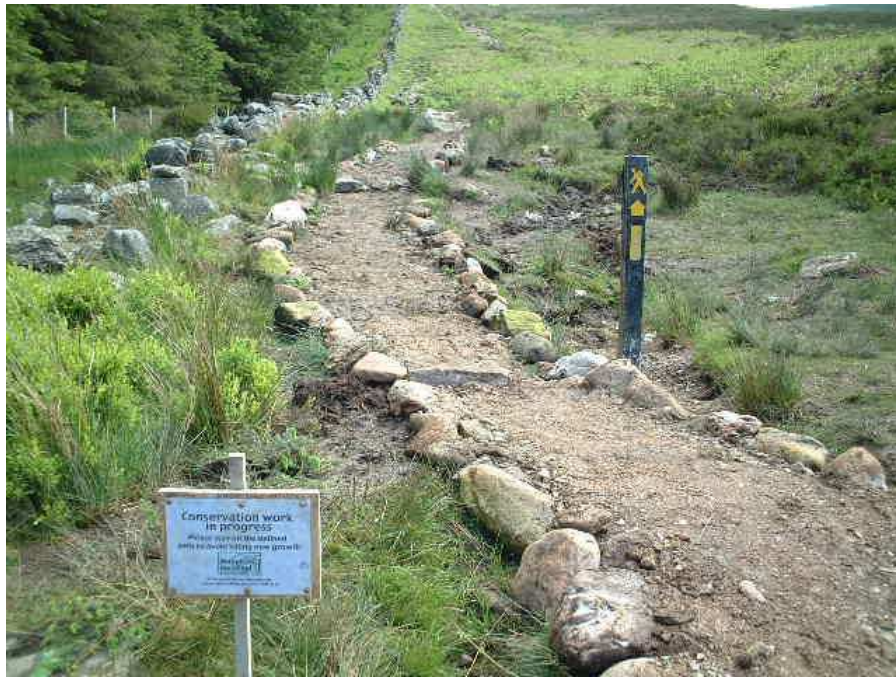
pic27: Mountain Meitheal treadway on the south bank of the Dargle

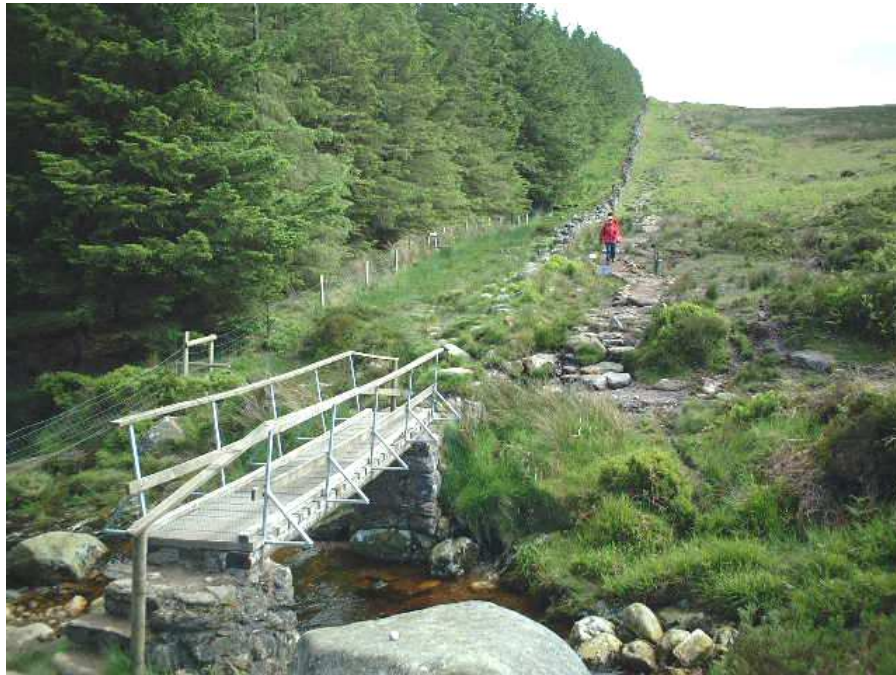
pic26: the bridge over the Dargle River; new treadway on the far bank

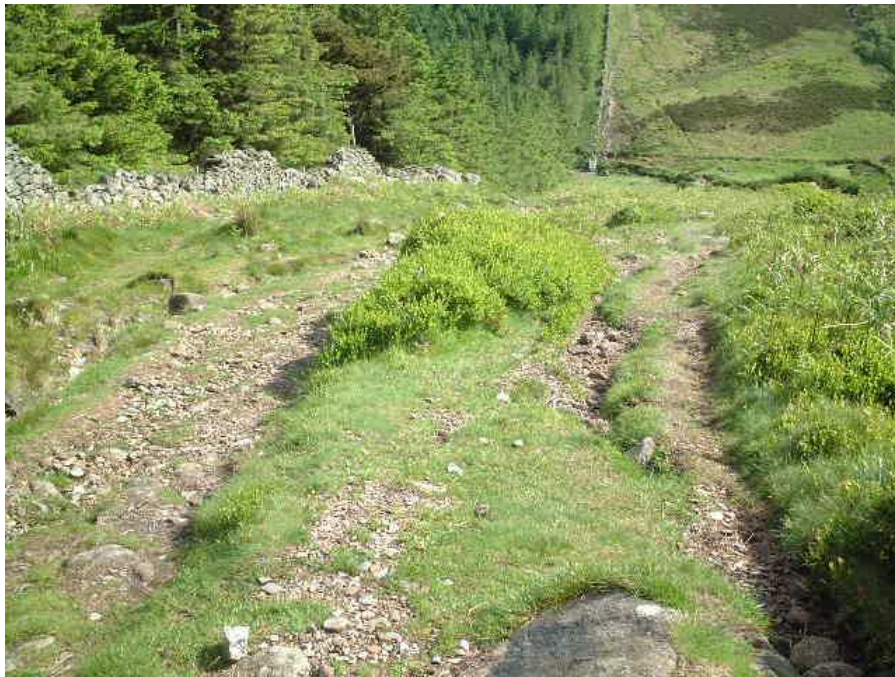
pic25 looking back down towards the start; multiple paths; total path width = 9m

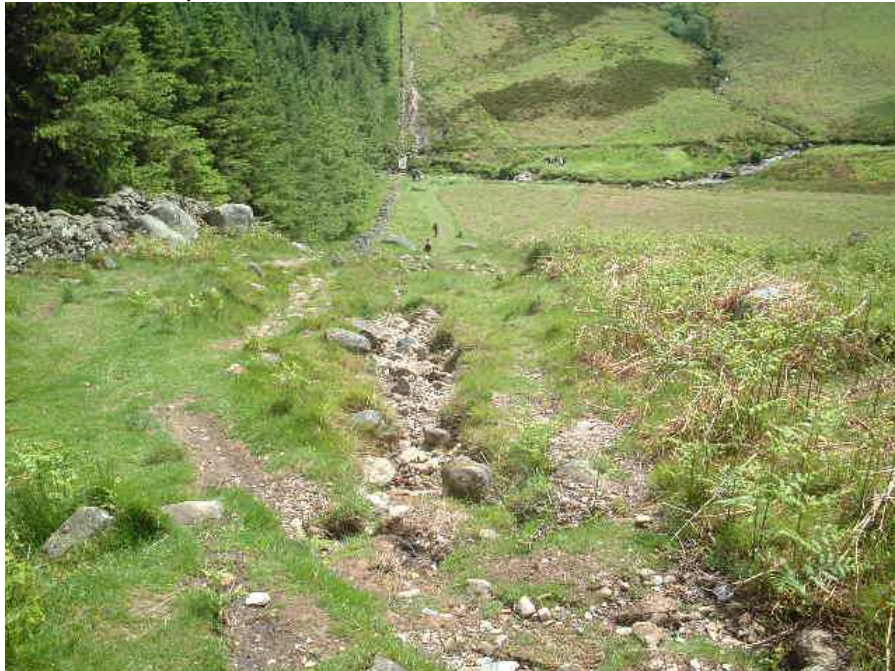
pic1 looking back down, shows the path; walkers turning into the forest to follow the Wicklow Way below; note water damage in the middle of the path

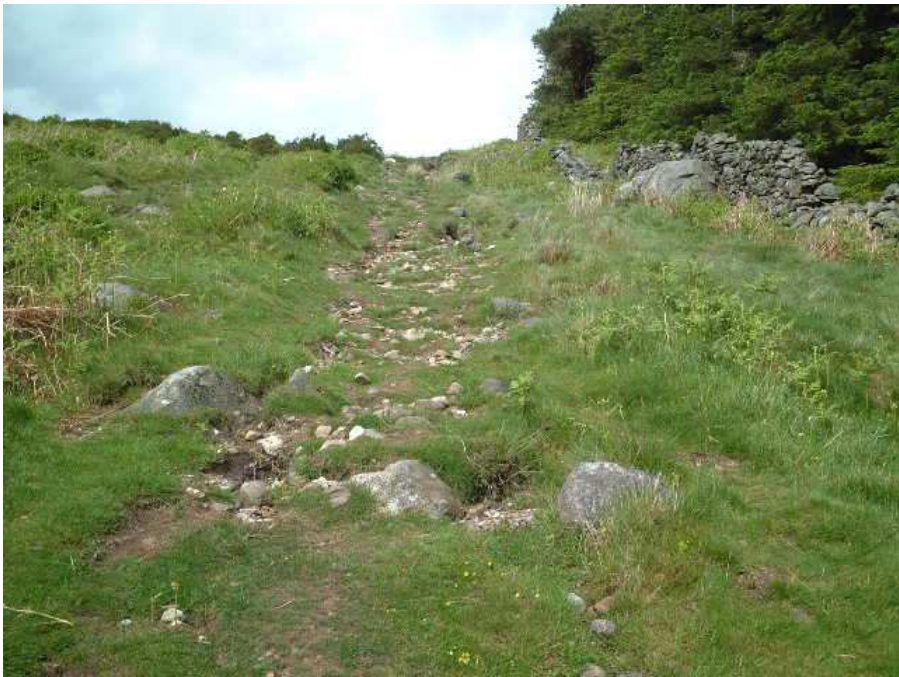
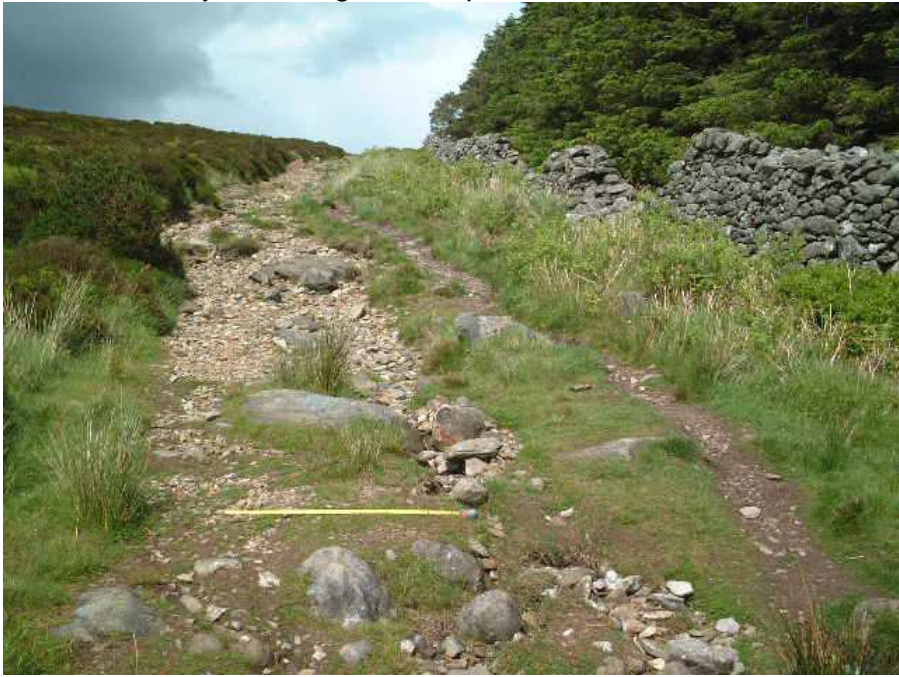
<p data-bbox="431 814 1198 846">pic2 looking up ahead shows the general state of the path</p>
8	50m on up	<p data-bbox="431 915 1312 982">pic3 looking up shows water damage on the left (tape = 1m) and a narrow walkway on the right; total path width = 4m</p>

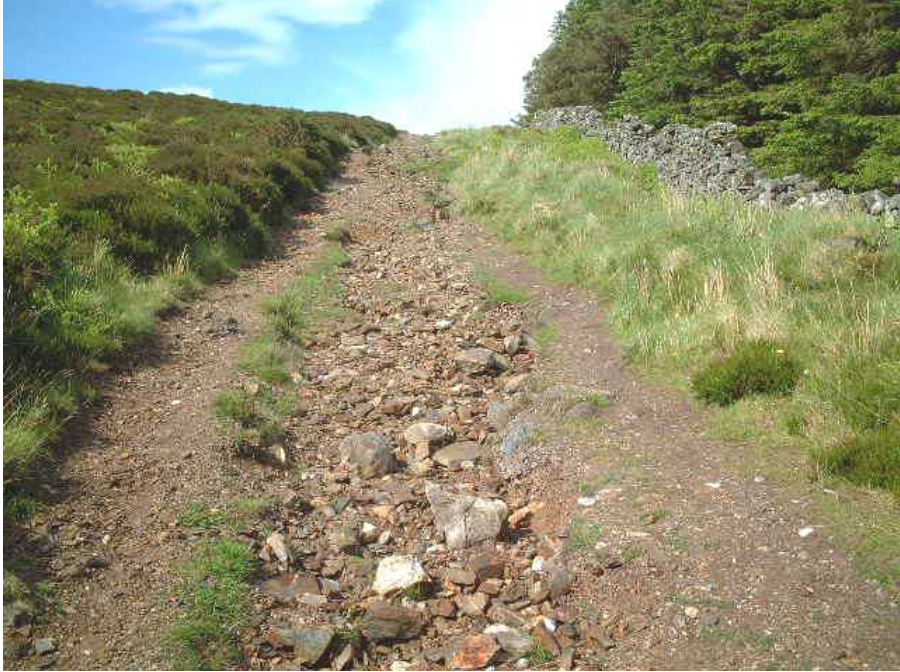
9	19274 12395	<p>pic23 looking up, shows walkways on either side, watercourse in the middle of the path; path width = 3m</p>

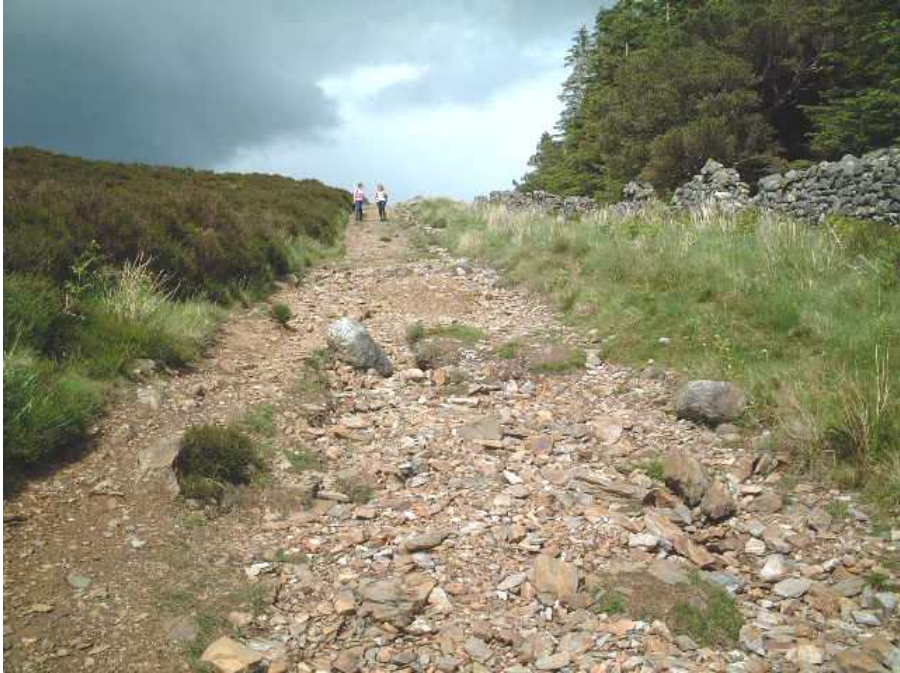
10	60m on up	<p>pic4 looking up shows water damage in the middle; pathways at either side; 2 walkers descending</p>

<p>note: the large, light coloured rock seen here in the middle of the picture is near the skyline in pic23, this to give an idea of location</p>

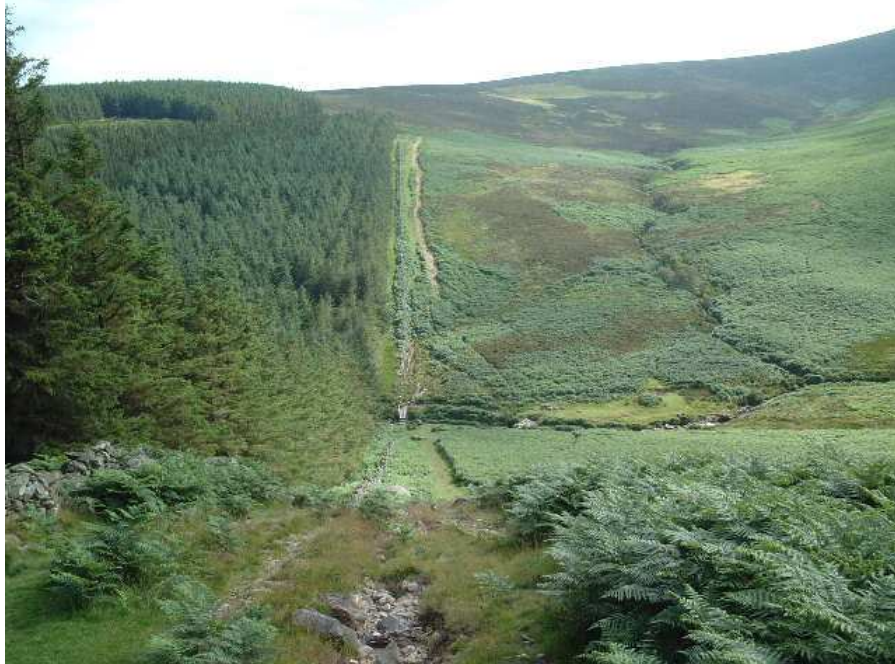
pic89, looking back down to the river, shows the slope

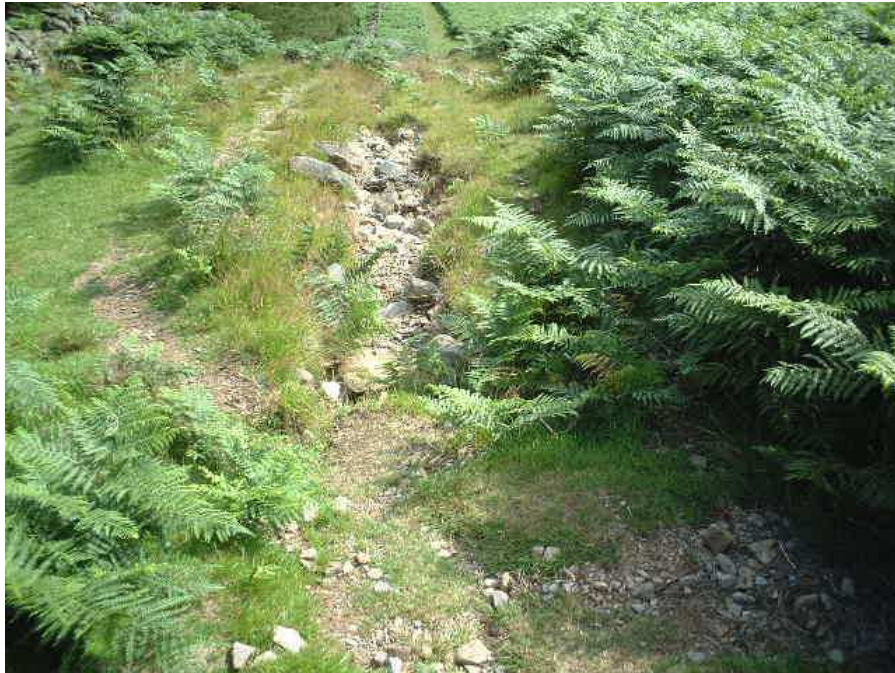
pic90 closeup, shows the path – mineral soil, grass and loose stone, bracken on either side

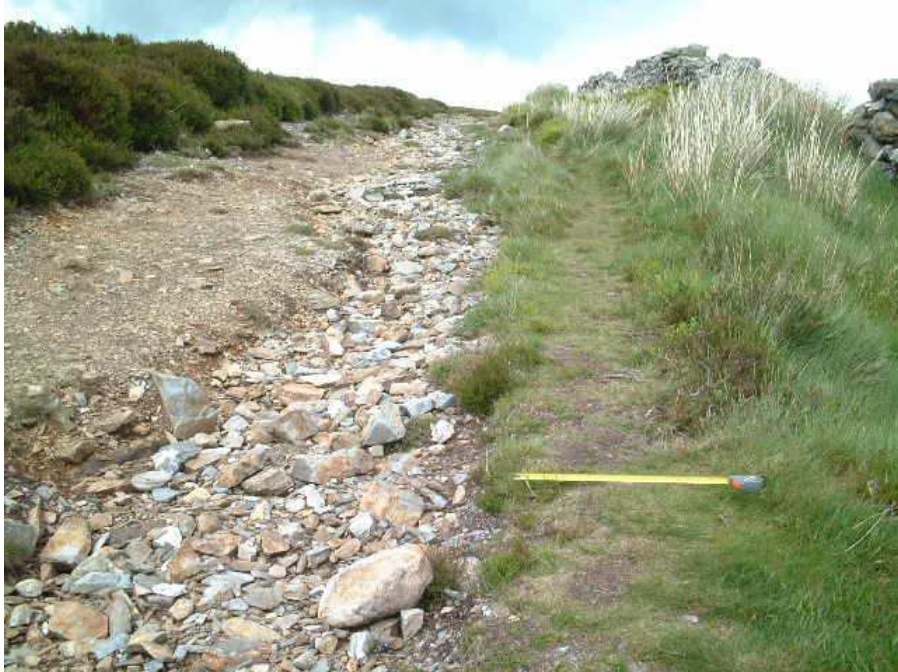
13	19313 12518	<p data-bbox="430 142 1291 210">At the top of the forest, pic5 closeup shows the path widening on the right hand side</p>

<p data-bbox="430 882 1315 945">New path on right-hand side (tape = 0.5m); loose stone and gravel in the watercourse in the middle; solid surface on the LHS</p>
14		<p data-bbox="430 987 1315 1050">pic91, above the forest, looking back down, shows the loose stone path about 1 metre wide; tape = 0.5m</p>

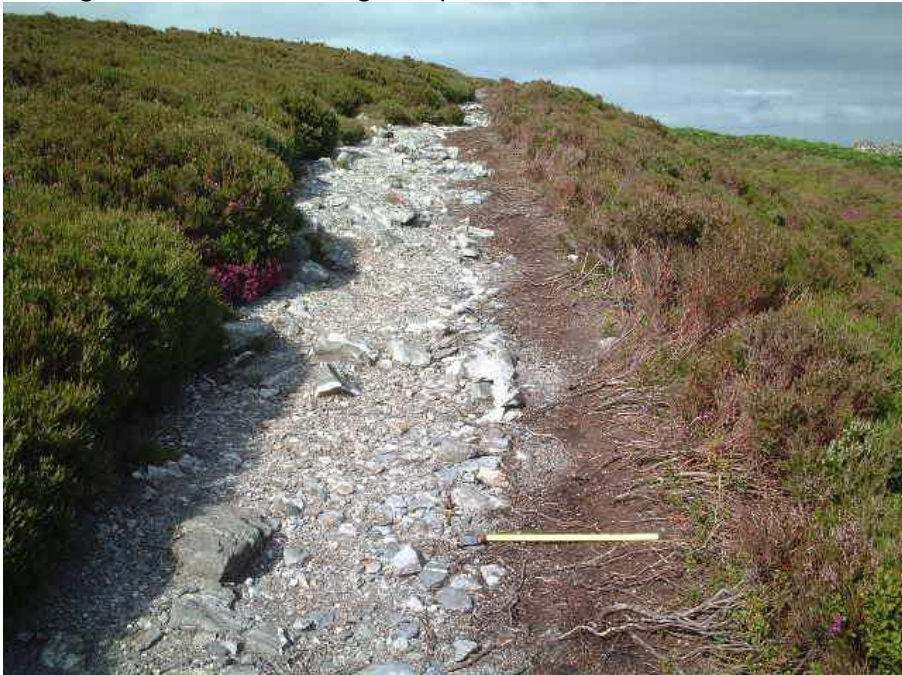
15	19354 12632	<p>50m on up from the last pic, pic92 looking up and ahead, shows the stony path now widening to 2 metres with a "soft shoulder" of damaged heather on the right; tape = 0.5m</p>

<p>(the path turns left up at the skyline in the photograph)</p>
16		<p>pic93 looking back towards the forest, shows the path now doubling in width from stone surface to peat</p>

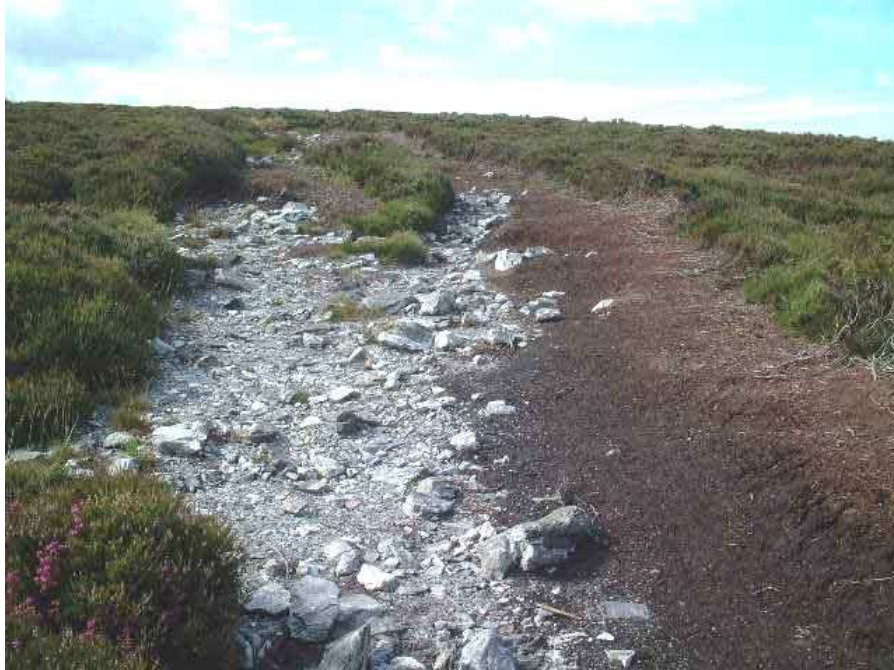
pic94 at the same place, shows the path ahead;

immediately ahead the path "splits", stone on the left, peat on the right, with an island of heather in the middle; the total path width is 5m here

(This is a snapshot of what the Djouce track, now 30m at its widest, probably looked like 15 years ago)

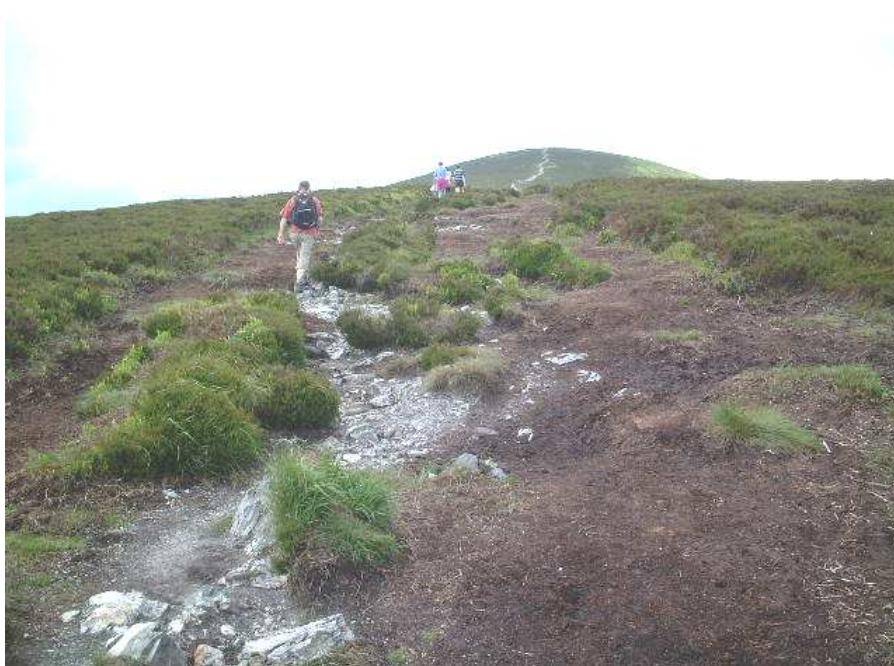
50m on from the last photograph, pic7 shows the path (peat, stone and islands of heather) breaking up and now widening out to 8m

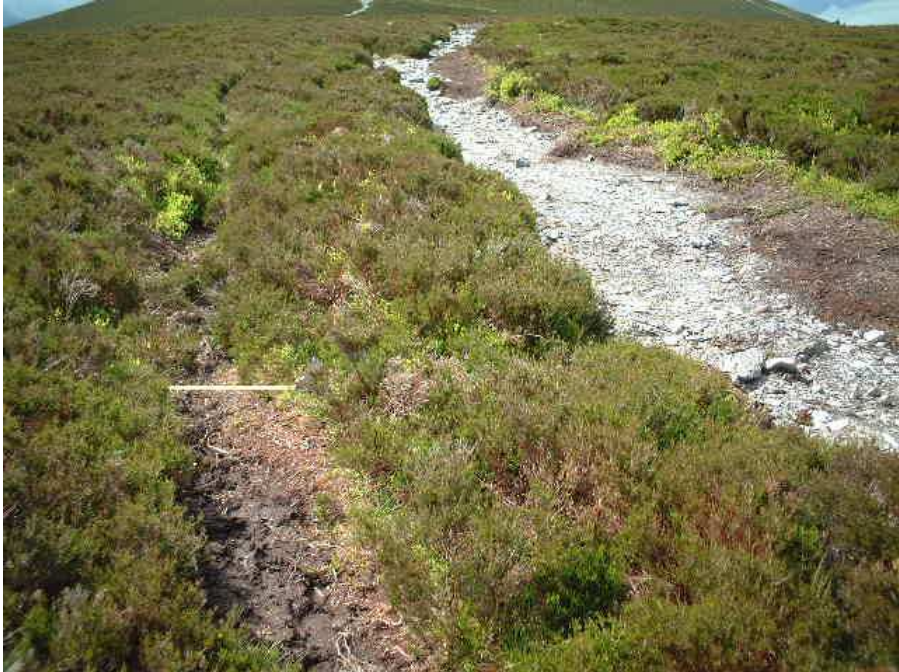
22		<p>at the end of the wide section, the path narrows; however pic8 shows a new path developing on the left; tape = 0.5m</p>

23	40m on	<p>where stone path is seen to change direction in pic8, there are three separate paths</p>
24		<p>pic97 shows a long distance view of the path ahead; note the wide areas of bare peat and damaged heather in the foreground</p>

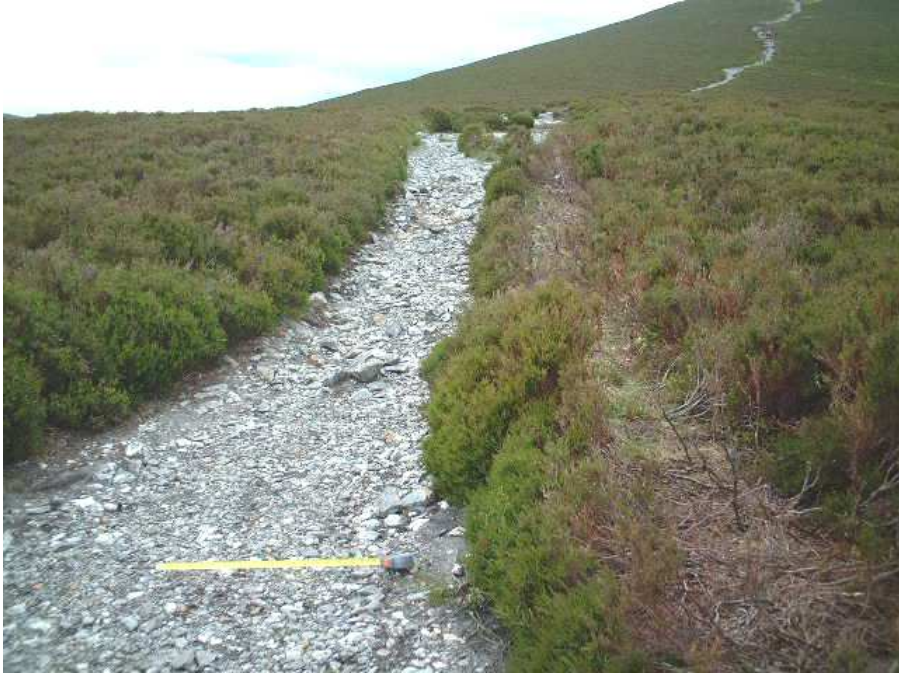
27	19100 12813	pic9 looking ahead shows new path forming in the heather on the right; tape = 0.5m

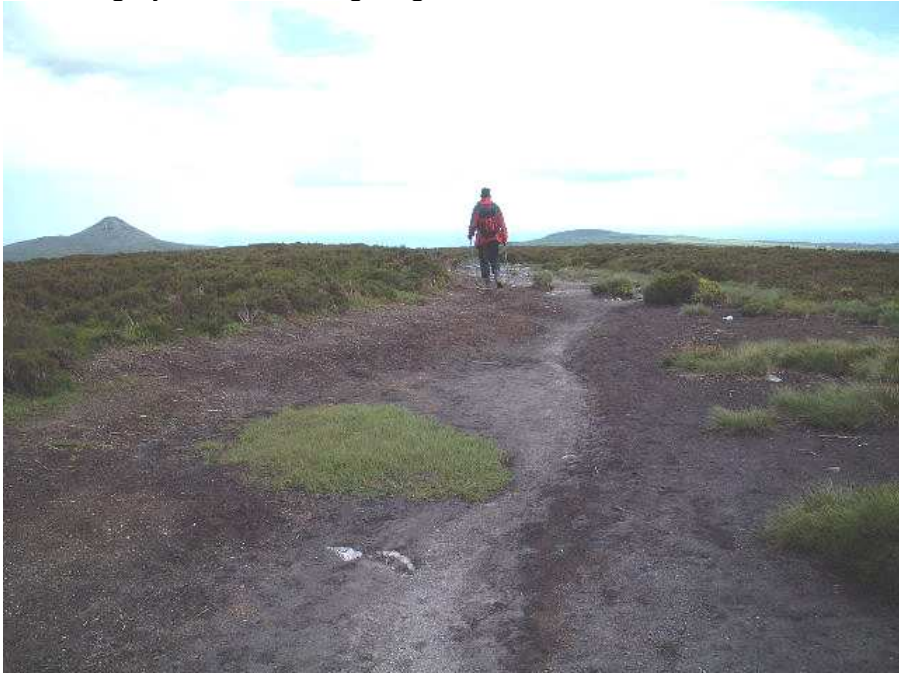
28	19052 12817	50m long stretch of stony path, 4-6m wide
29	19008 12833	pic10 looking back shows the path crossing a wide peaty area, 40m long by 10m wide; Big Sugarloaf back left

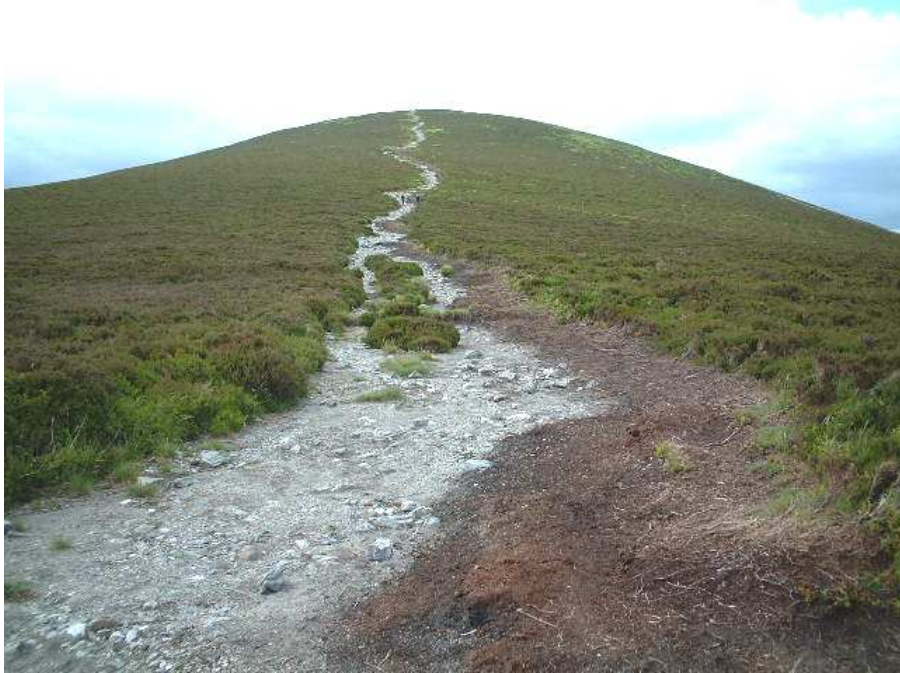
30	same	<p data-bbox="430 142 1312 279">pic11 looking ahead shows the path to the summit; note the "soft shoulder" of peat on the right stretching from the foreground to the middle distance; also the "islands" of grass / heather in the middle distance;</p>

<p data-bbox="430 947 1214 982">the path width narrows (in foreground of photograph) to 5m</p>
31		<p data-bbox="430 1052 1286 1121">at the "islands" mentioned in the previous point, pic12 shows the path ahead; note the damage on the right</p>

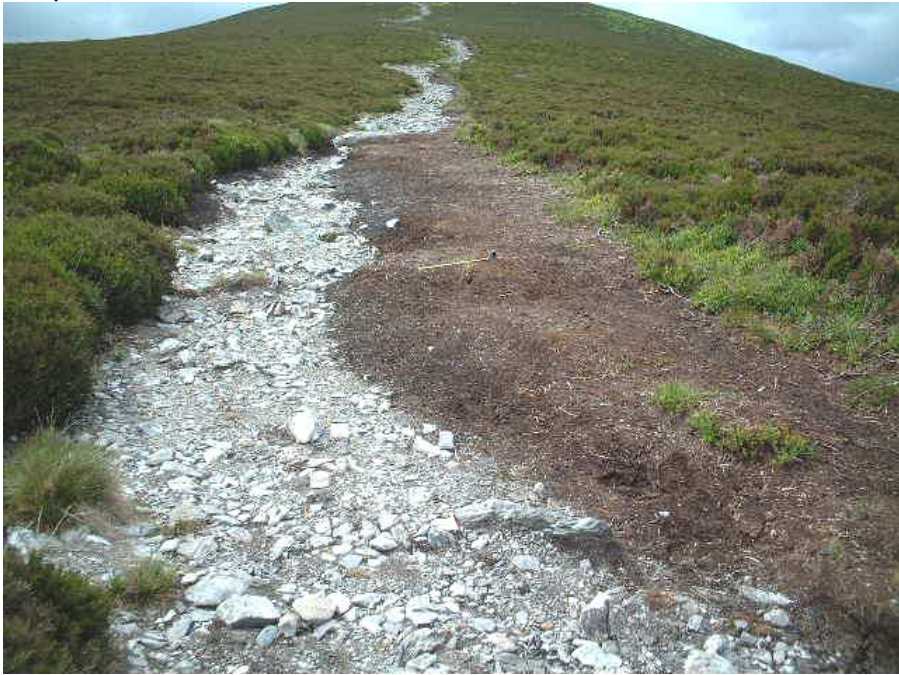
<p>32</p>	<p>18937 12861</p>	<p>pic13 shows the damaged heather and bare peat (tape = 0.5m); this area needs to be protected soon to stop a dramatic widening of the path</p>

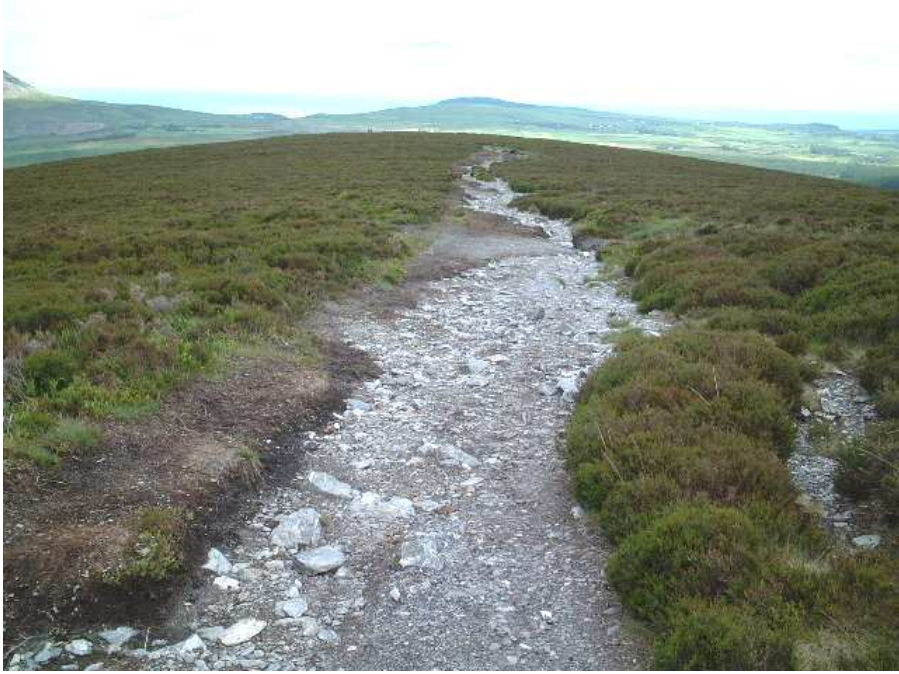
<p>33</p>	<p>18900 12877</p>	<p>pic14 looking back down shows the general widening of the path, the vulnerable peat areas on the left; note also the separate path on the right</p>

<p>the width of the stone path at the bottom of the photograph is 1.5m, soon to be widened...?</p>

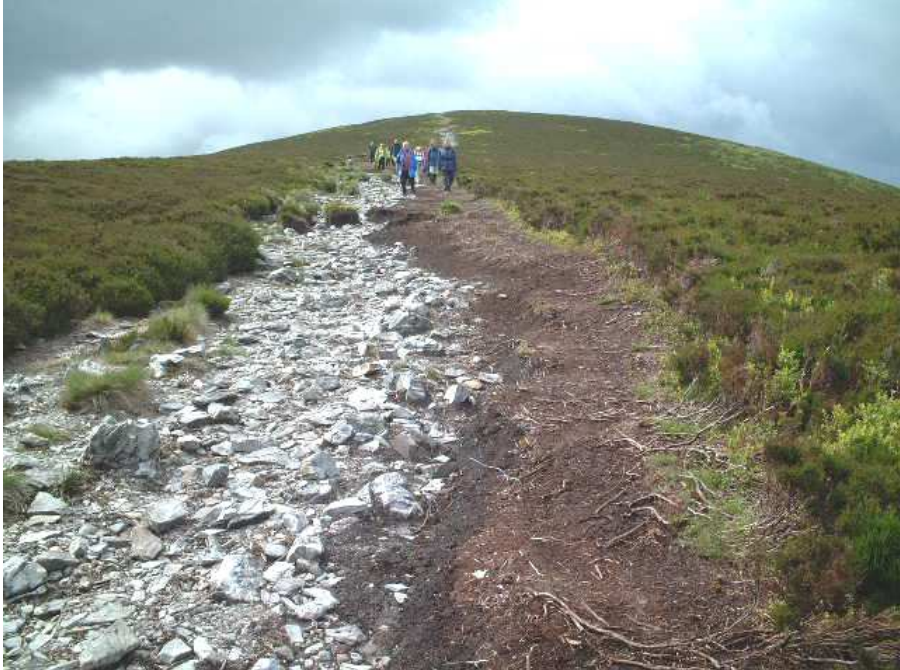
<p>34</p>	<p>18845 12905</p>	<p>(at a grassy step on the right of the path), the beginning of a section with peat on the right of the path and stone on the left;</p>

<p>pic15 shows a group of walkers descending, the peat surface more comfortable to walk on than the rough stone</p>
<p>35</p>	<p>30m on up</p>	<p>pic16 shows the walkers passing by, all treading on the peat, no-one on the stone</p>  
<p>36</p>	<p>18670 12979</p>	<p>the end of the section with peat on the right, stone on the left; path width here = 8m</p>

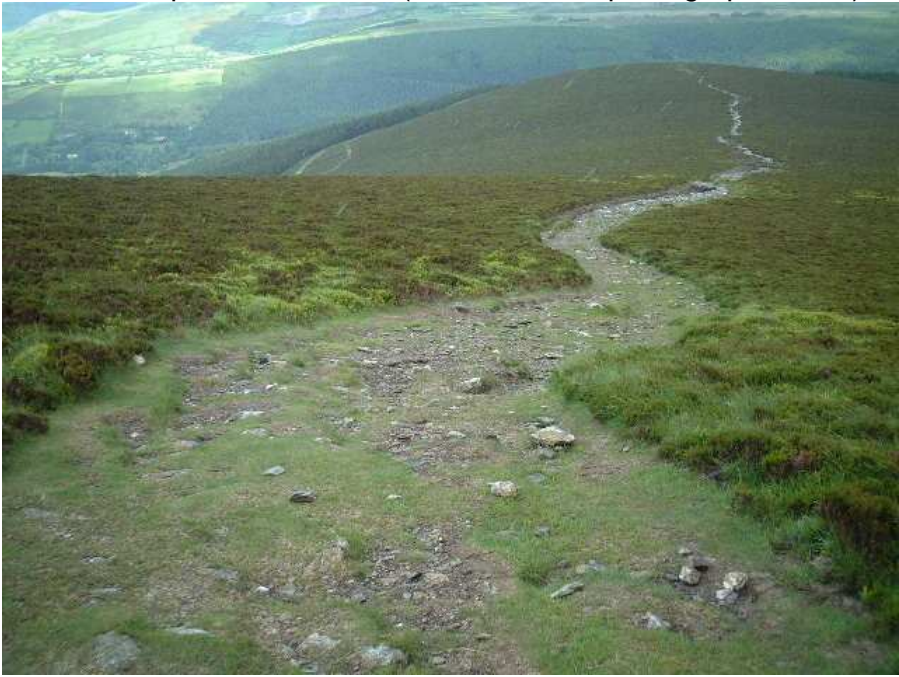
37	18600 13022	path now narrows to 5m, mainly stone with about 1m of peat on the RHS
38	18500 13062	<p>pic21 looking back down; the path surface of grass and rock on mineral soil; path width = 4m (unseen in the photograph: rain)</p>
